Request List

Roof Materials

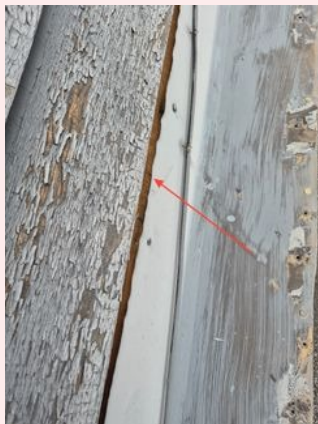
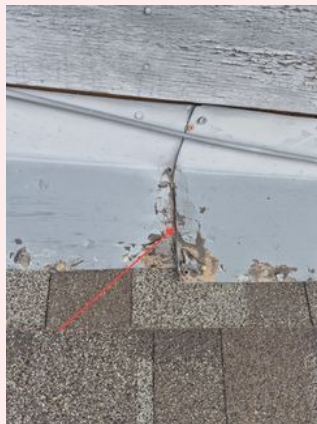
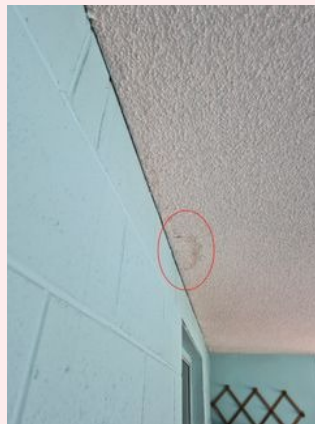
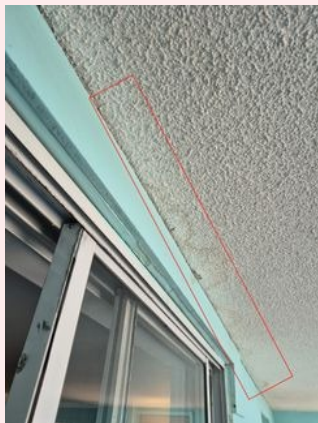
(RCG-1) Major Concern :

The headwall flashing has separated from the wall, creating a pathway for moisture to enter the structure. Signs of moisture damage are noted on the interior beneath this section. A qualified roofing contractor should repair or replace the flashing to restore proper weather protection.
