# Sample Report

This report is prepared exclusively for **Clients**  
Inspected On: **04-04-2026**

Outline Home Inspections  
(705) 879-6142

Dillon Koolhaas

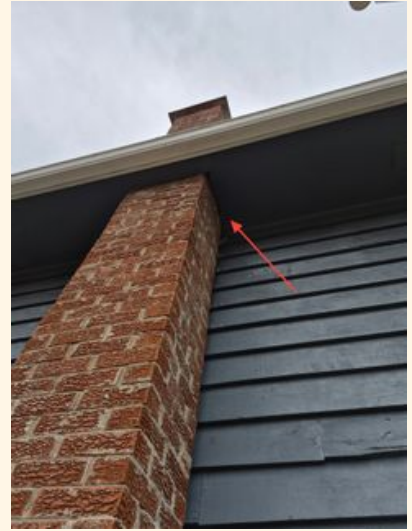
### 🔧 (E-2) Repair:

Openings were noted in the eaves of the house that need to be sealed up to exclude rodents from getting into the attic.

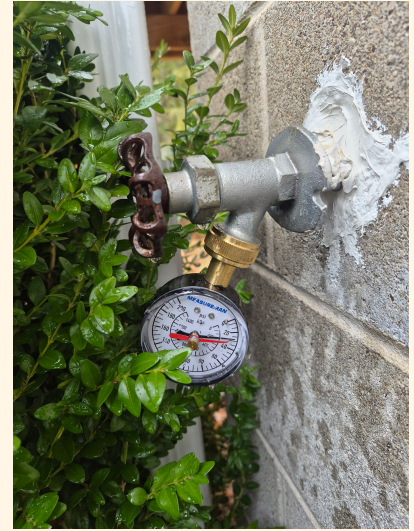
#### 🔧 (E-4) Repair:

##### **LOW WATER PRESSURE NOTED**

Low water pressure was noted. A bare minimum of 30 PSI is recommended to serve the home. Often, well systems require servicing and repair to recharge storage tanks and even update pump systems. I recommend having the well system further evaluated and repaired as recommended by a well specialist.

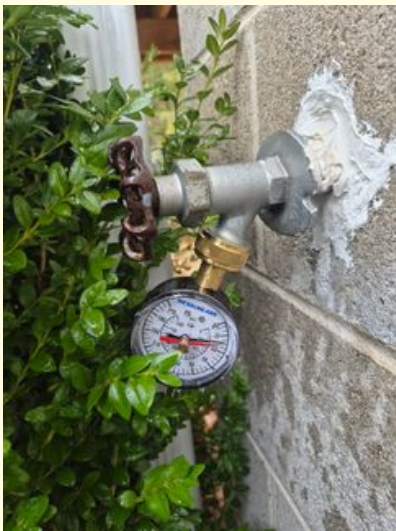
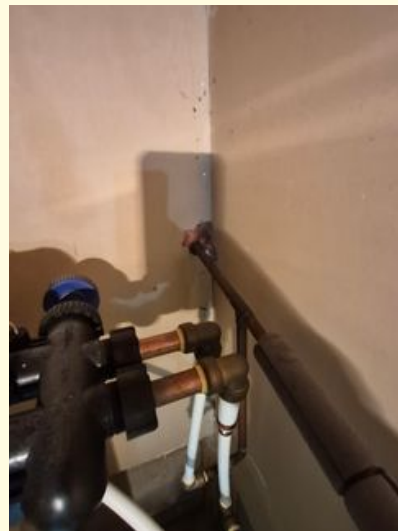
#### 🏠 (E-5) Improve or Upgrade: **OLDER HOSE BIBS NOTED**

Older hose bibs were noted on this building. Updating the hose bibs is recommended. Modern hose bibs are typically "frost free," which are (arguably) more resistant to bursting in cold weather. They also have important vacuum breakers installed which can prevent water from your hoses backing into your water supply system. In the meantime, be sure to winterize your hose bibs during cold weather to prevent from freezing.

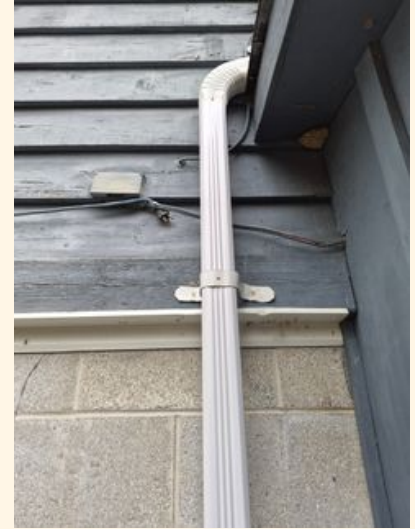
### 🔧 (E-6) Repair:

The exterior receptacle has been installed at a height that prevents safe and convenient access from ground level. Additionally, non-metallic sheathed cable was observed running exposed along the exterior wall surface. This wiring method is not suitable for outdoor exposure and is vulnerable to physical and environmental damage. Recommend evaluation by an electrical contractor.

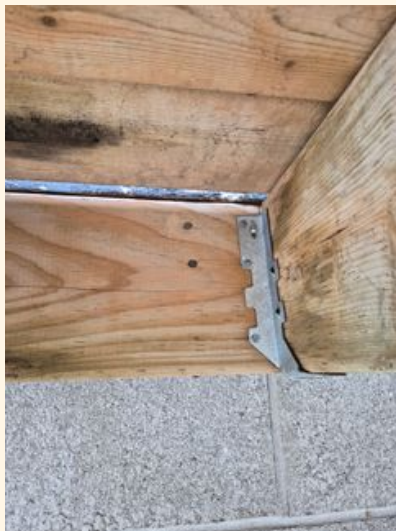
🔧 (DPB-1) Repair: **DECK LEDGER BOLTS NEEDED**

The deck ledger board has not been reliably connected to the house. This risks deck failure as the ledger attachment to the house can pull free. I recommend installing an attachment system that conforms to recommended minimum standards. The Town of Orangeville provides an excellent [Deck Construction Guide](#) for reference.

Hire a qualified deck contractor to further evaluate.

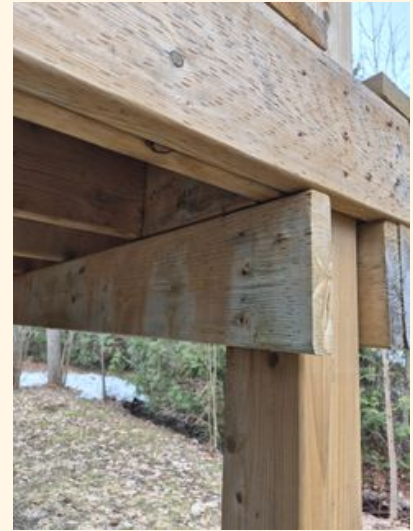
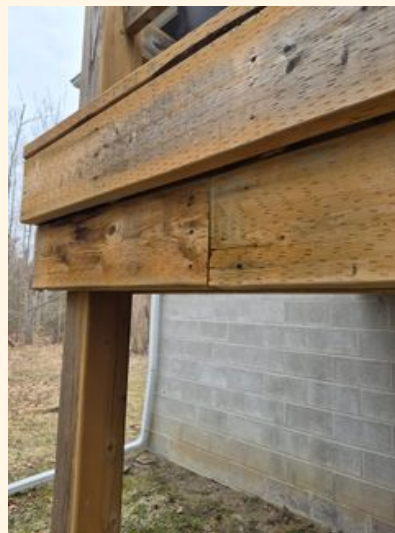
🔧 (DPB-2) Repair: The deck beams do not appear to be reliably connected to the posts. The beam is not bearing on the posts and nails were used for connection. When not done to normal standards it is difficult to predict how this connection will perform. The Town of Orangeville provides an excellent [Deck Construction Guide](#) for reference.

Hire a qualified deck contractor to further evaluate.

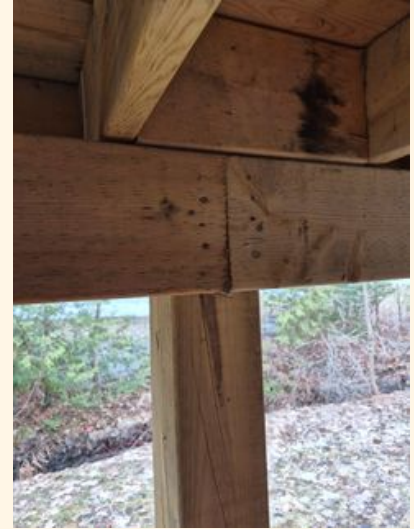
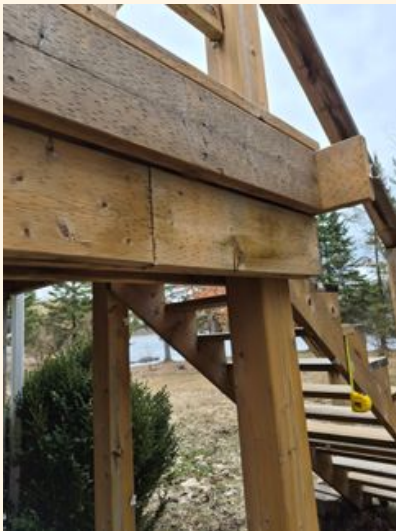
✂️ **(DPB-3) Repair:** Splices were observed in the deck girder spans. Girder members should be continuous or properly supported at posts; splices located between supports can weaken the span and reduce load-carrying capacity. This condition may compromise the structural performance of the deck.

The illustration above depicts a butt joint or splice improperly located within a girder span. Butt joints in a girder span are generally not permitted unless specially engineered. A butt joint or splice should be positioned to land at the posts.

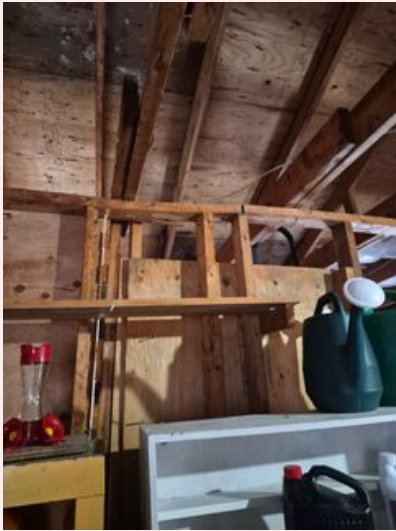
**⚠️ (G-1) Major Concern:** Extensive repairs are needed to the detached garage. Hire a licensed general contractor to further evaluate and repair. Examples of observations noted during inspection include:

*roof joists bearing weight on non structural wall*

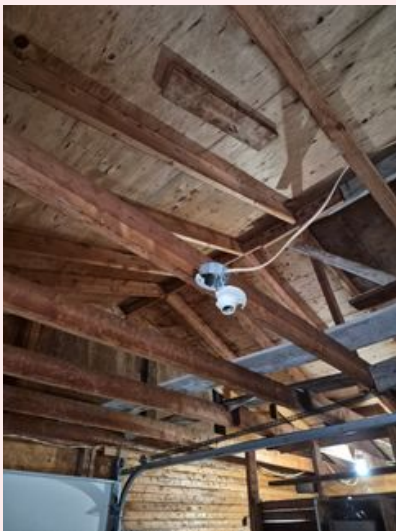
*damaged light with live electrical*

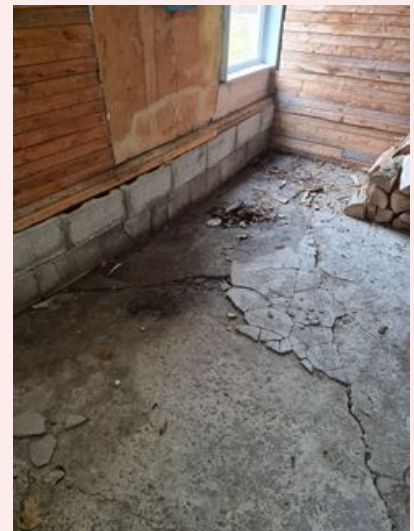
*Garage foundation deflecting*

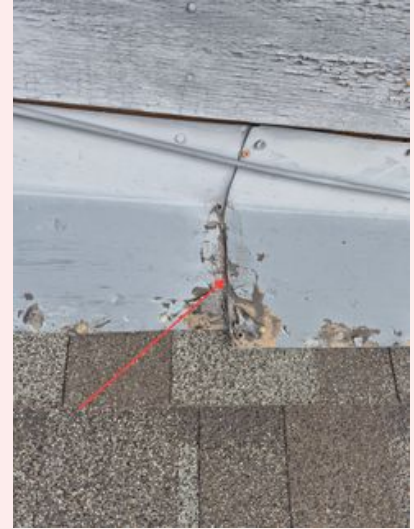
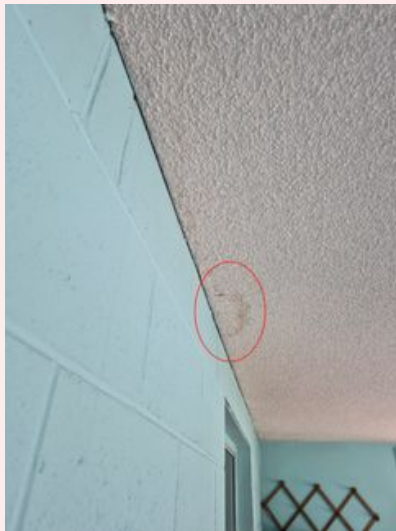
**⚠️ (RCG-1) Major Concern:** The headwall flashing has separated from the wall, creating a pathway for moisture to enter the structure. Signs of moisture damage are noted on the interior beneath this section. A qualified roofing contractor should repair or replace the flashing to restore proper weather protection.

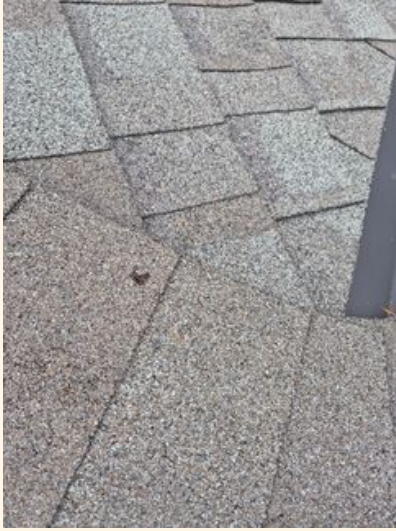
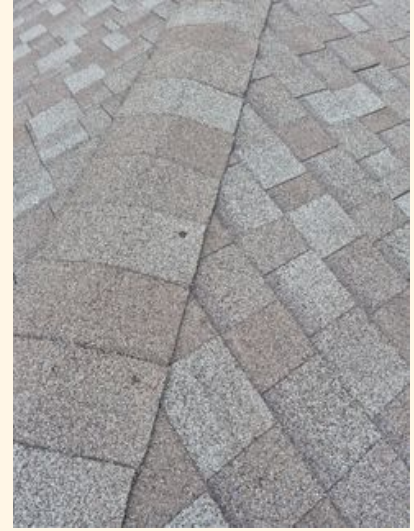
**🔧 (RCG-2) Repair:** All exposed fasteners on the roof should be sealed with mastic.

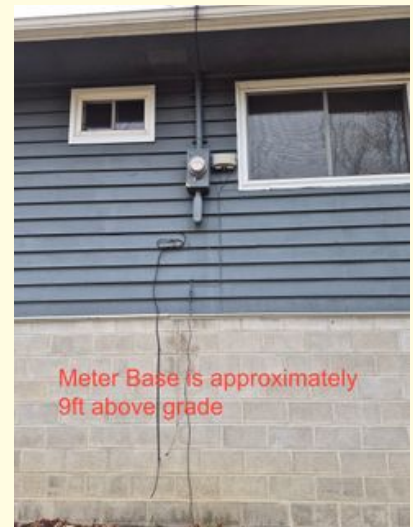
The electrical meter base is installed higher than the acceptable mounting range typically required by the local supply authority. Meter bases must be positioned so the meter remains safely and readily accessible from finished grade. Adjustment is recommended to ensure proper accessibility for service personnel.

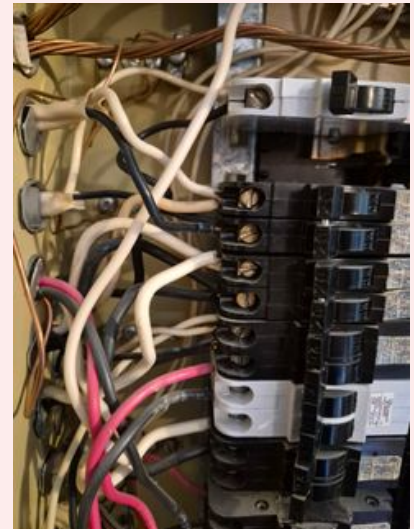
### (ES-2) Major Concern: **ELECTRIC PANEL UPDATING IS RECOMMENDED**

A [Federal Pioneer Electric Stab Lok](#) brand electric panel was noted. This is an obsolete brand of

panel with a reputation for failing and malfunctioning breakers. Stab Lok electric panels are at greater risk of electrical fire and statistically less safe than any new electric panel. I recommend additional inspection of this electrical service by a licensed electrical contractor; updating this panel is recommended for improved reliability and safety. A number of observations were noted during the inspection:

*burnt neutral wire*

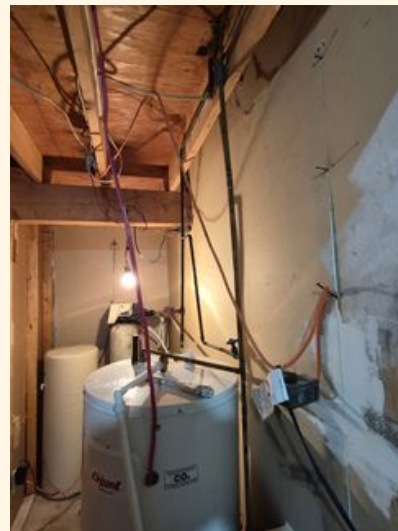
## 🔧 (ES-3) Repair:

Have the electrical bonding system checked by a licensed electrician. Adequate bonding could not be verified at the main water pipe or the pipes by the water heater. This is an important safety feature to ensure safe control of stray voltage on metal systems in the house.

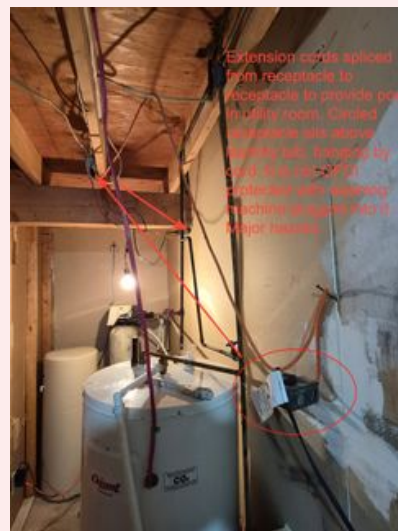
### WIRING REPAIRS NEEDED

Several repairs are needed to the wiring system. Unconventional wiring and receptacles are noted in the attached image. Non-standard cables and splicing techniques are being used.

- The types of wiring repairs found today indicate work was likely done here by someone who was not a licensed electrician - it would be wise to check for any permit records of history
- The extent and types of repair items noted during inspection suggest there will be additional concealed repair work here.

Hire a licensed electrical contractor to further evaluate and repair.

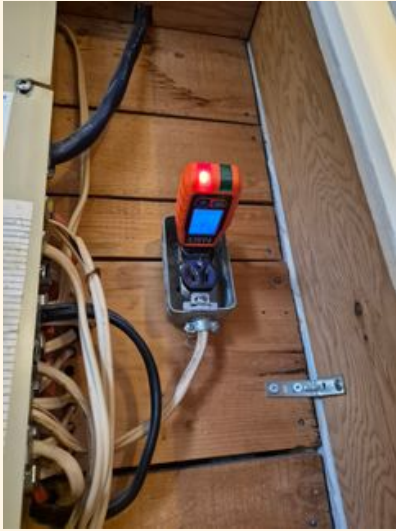
**✂️ (EDF-3) Repair: REVERSE POLARITY**

Reverse polarity was noted at one of the electric receptacles. This is when the hot and the neutral wires have been wired backwards. This is a potential safety issue that should be corrected by a licensed electrical contractor.

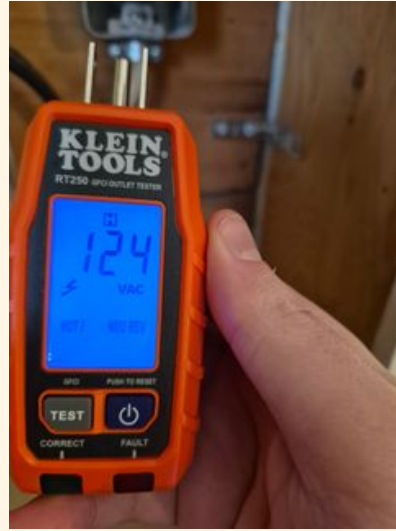
*Receptacle next to electrical panel*

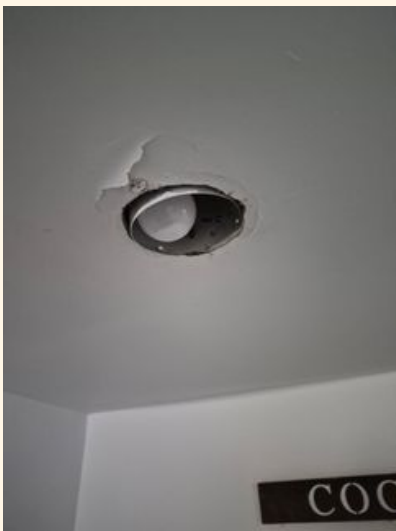
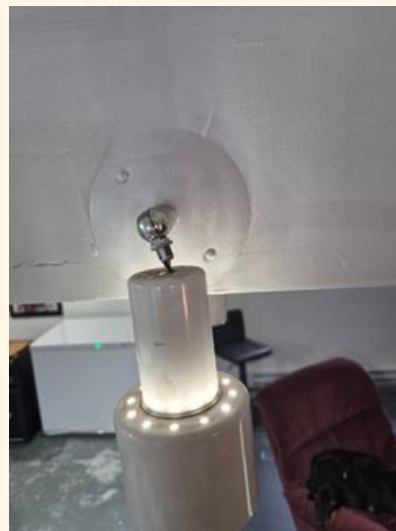
**✂️ (EDF-4) Repair: DAMAGED LIGHT FIXTURES**

Damaged light fixtures were noted. Repair / replace as needed.

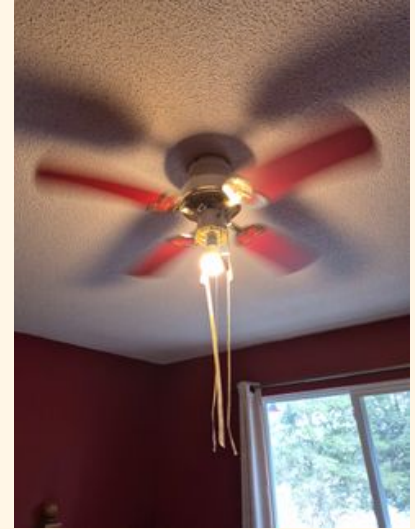
### 🔧 (EDF-7) Repair:

The ceiling fan in the bedroom is wobbling during operation at high speed. This can be a simple matter of balancing the fan blades, but it could also indicate an inadequately secured fan, which can present a safety hazard. Have this further evaluated and repaired as recommended by a qualified electrical contractor.

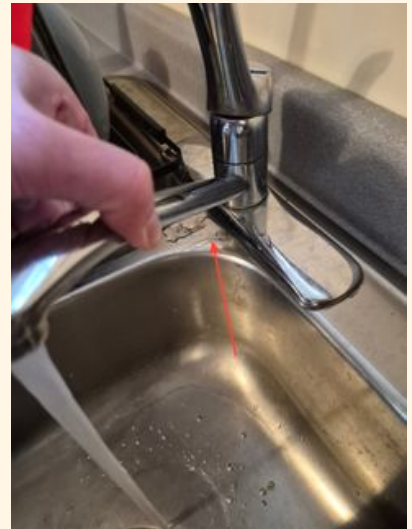
The kitchen sink faucet handle is leaking and needs to be repaired or replaced.

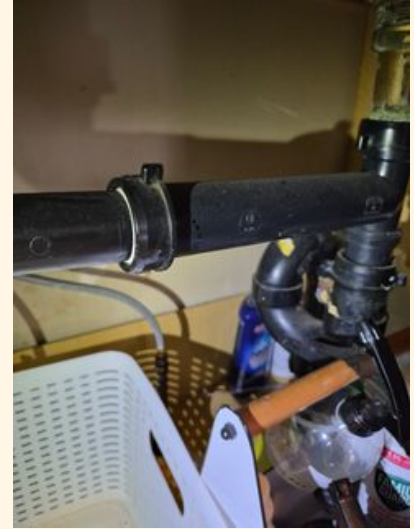
### (K-2) Repair: **S-TRAP CONFIGURATION NOTED**

An S-trap was noted in the kitchen sink. This is an older style of waste piping that risks siphoning the trap and is no longer allowed. This should be further investigated and repaired by a licensed plumber to ensure reliable performance. Often an air admittance valve can be used to correct this configuration. Please note that trap siphoning could allow sewer gas to enter the house.

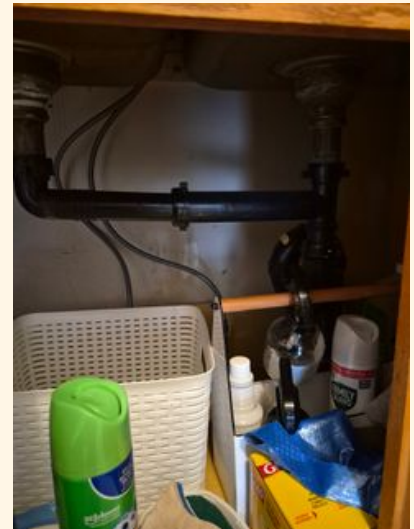
### 🔧 (K-3) Repair: **MISSING ISOLATION VALVES**

Hire a qualified plumber to add proper isolation valves for future serviceability.

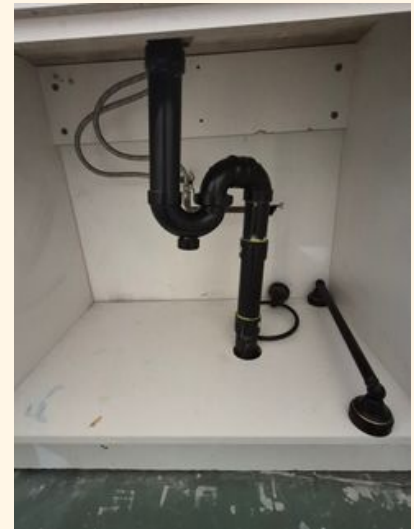
An S-trap was noted in the basement bathroom sink. This is an older style of waste piping that risks siphoning the trap and is no longer allowed. This should be further investigated and repaired by a licensed plumber to ensure reliable performance. Often an air admittance valve can be used to correct this configuration. Please note that trap siphoning could allow sewer gas to enter the house.

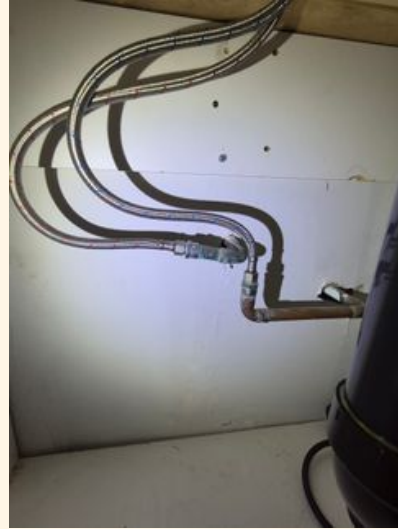
### 🔧 (BB-2) Repair: **MISSING ISOLATION VALVES**

Hire a qualified plumber to add proper isolation valves for future serviceability.

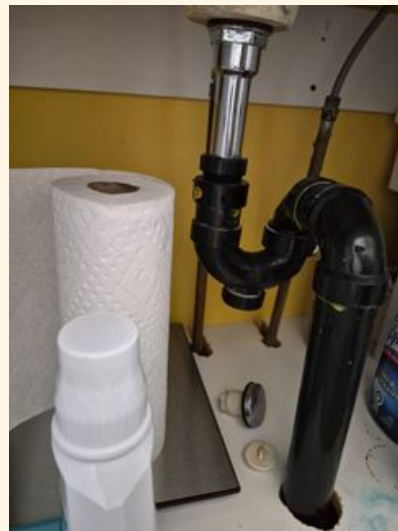
An [S-trap](#) was noted in the main bathroom sink. This is an older style of waste piping that risks siphoning the trap and is no longer allowed. This should be further investigated and repaired by a licensed plumber to ensure reliable performance. Often an air admittance valve can be used to correct this configuration. Please note that trap siphoning could allow sewer gas to enter the house.

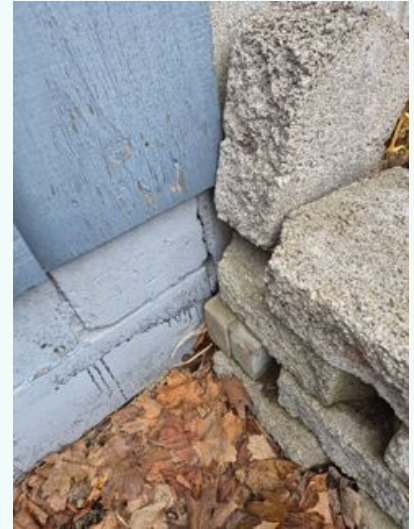
- Monitor these cracks. If continued movement is noted, seek additional opinions from a structural engineer or qualified contractor to determine an accurate scope and urgency for repair.

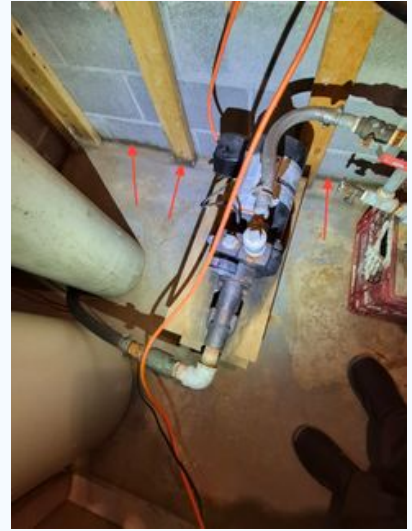
- This basement does not look well-suited to finishing without first waterproofing.
