Inspection report for the property at
Sample Report

This report is prepared exclusively for **Clients**
Inspected On: **04-04-2026**

Outline Home Inspections
(705) 879-6142

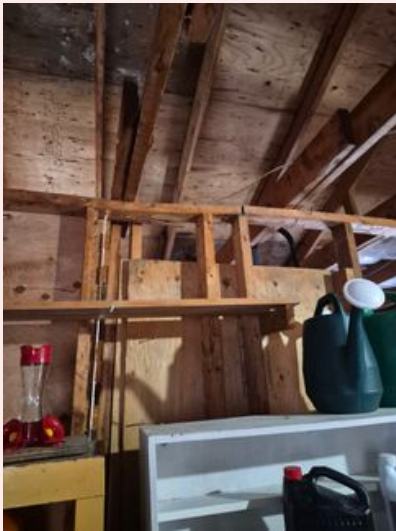
roof joists bearing weight on non structural wall

⚠️ **G-1 Garage General:** Extensive repairs are needed to the detached garage. Hire a licensed general contractor to further evaluate and repair. Examples of observations noted during inspection include:

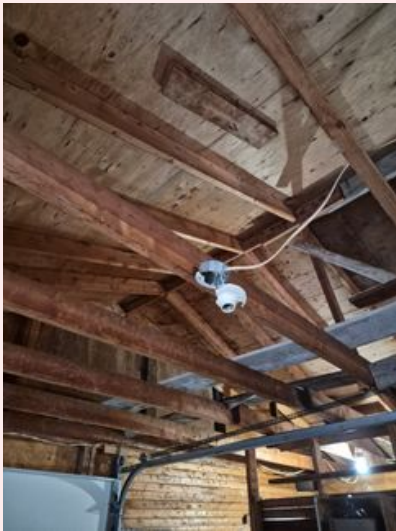
damaged light with live electrical

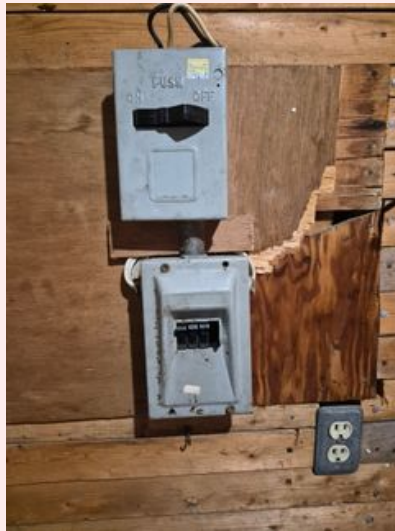
Wrong screw type in subpanel, missing screws, missing breaker plates, unprotected cables in vulnerable area, poor mounting surface.

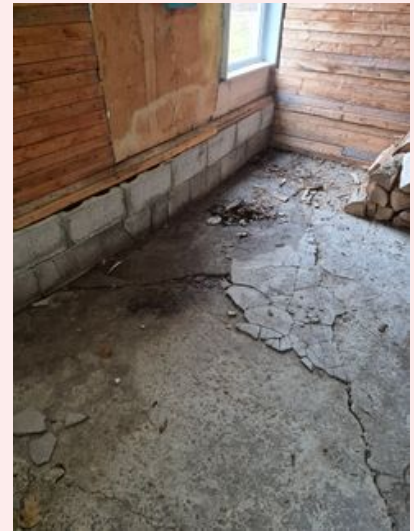
Garage foundation deflecting

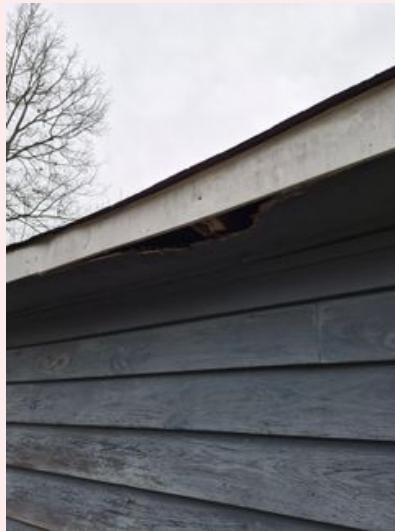
large opening in damaged soffit

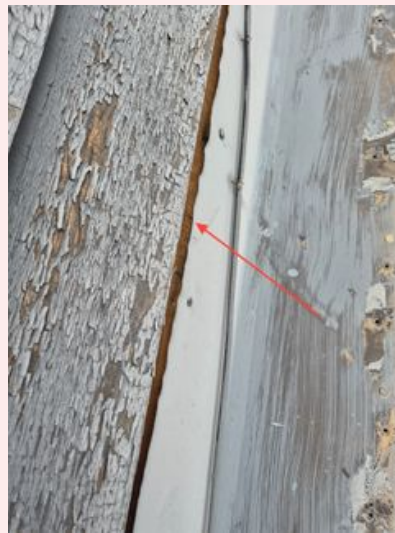
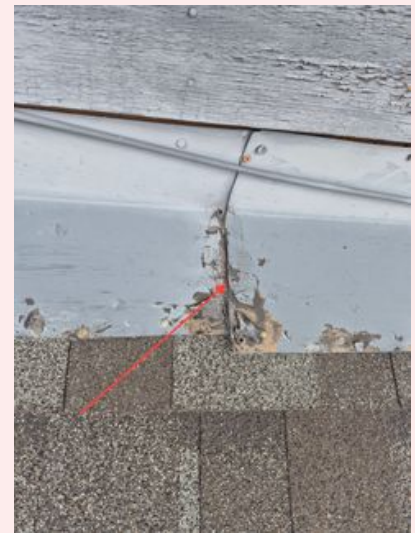
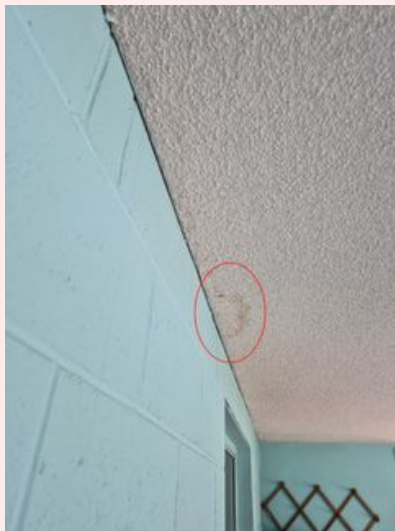
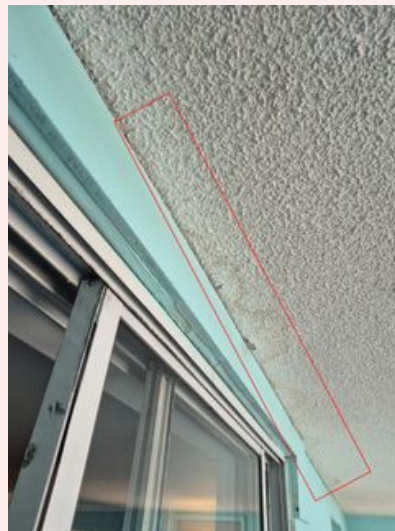
⚠️ RCG-1 Roof Materials: The headwall flashing has separated from the wall, creating a pathway for moisture to enter the structure. Signs of moisture damage are noted on the interior beneath this section. A qualified roofing contractor should repair or replace the flashing to restore proper weather protection.

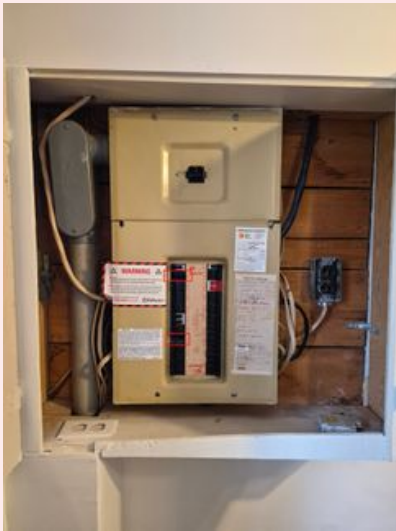
Openings in dead front cover

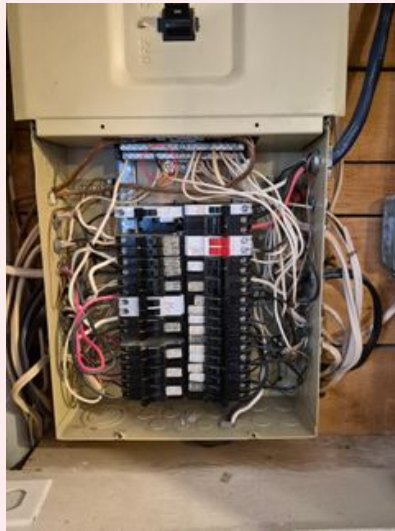
burnt neutral wire

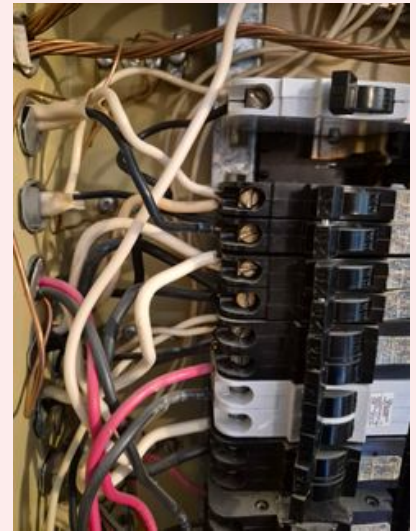
multiple double tapped hot wires

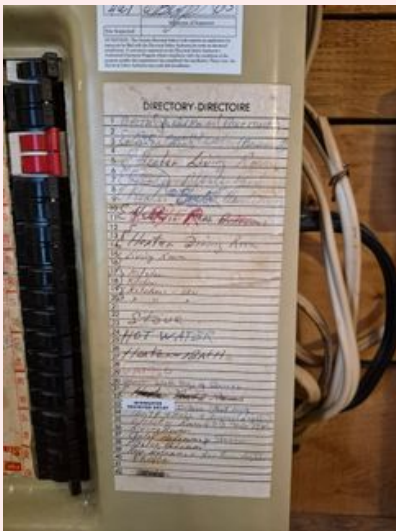
Poorly labelled panel

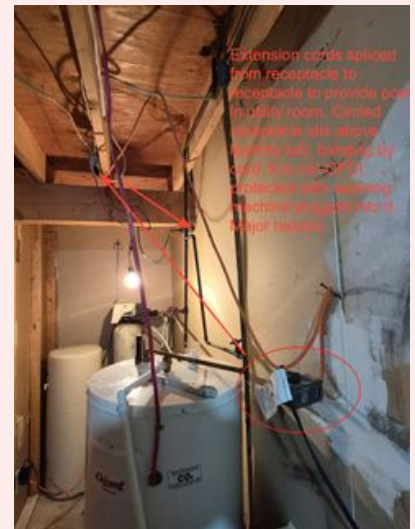
Several repairs are needed to the wiring system. Unconventional wiring and receptacles are noted in the attached image. Non-standard cables and splicing techniques are being used.

- The types of wiring repairs found today indicate work was likely done here by someone who was not a licensed electrician - it would be wise to check for any permit records of history
- The extent and types of repair items noted during inspection suggest there will be additional concealed repair work here.

Hire a licensed electrical contractor to further evaluate and repair.

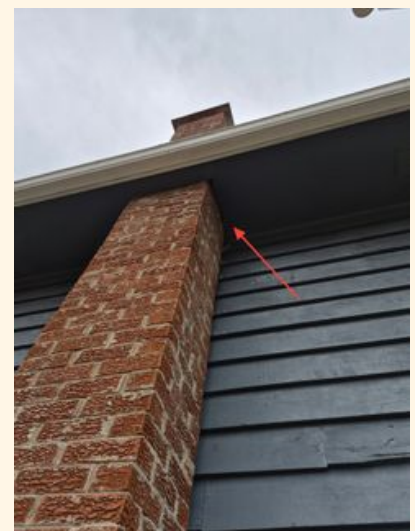
Openings were noted in the eaves of the house that need to be sealed up to exclude rodents from getting into the attic.

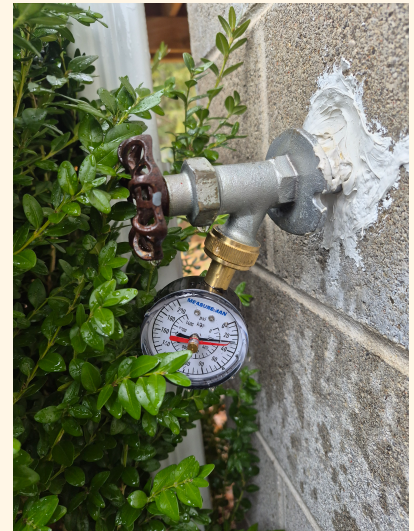
Low water pressure was noted. A bare minimum of 30 PSI is recommended to serve the home. Often, well systems require servicing and repair to recharge storage tanks and even update pump systems. I recommend having the well system further evaluated and repaired as recommended by a well specialist.

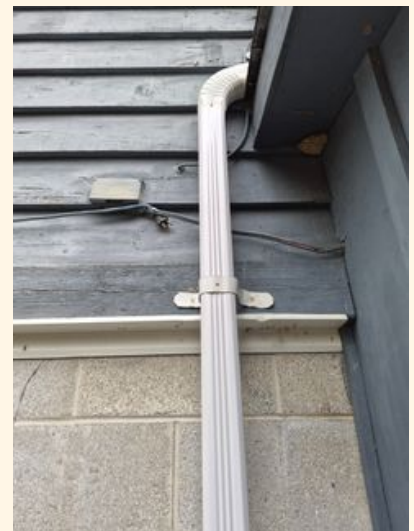
The exterior receptacle has been installed at a height that prevents safe and convenient access from ground level. Additionally, non-metallic sheathed cable was observed running exposed along the exterior wall surface. This wiring method is not suitable for outdoor exposure and is vulnerable to physical and environmental damage. Recommend evaluation by an electrical contractor.

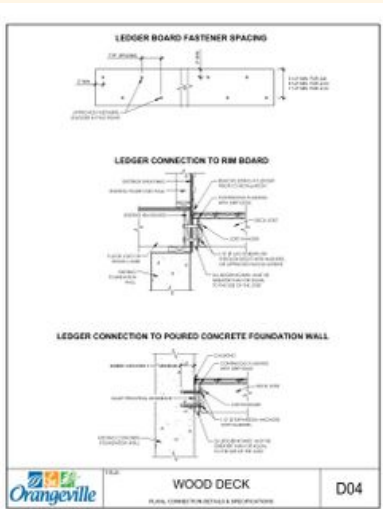
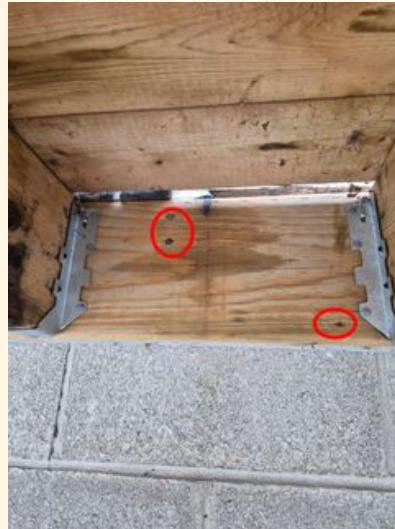
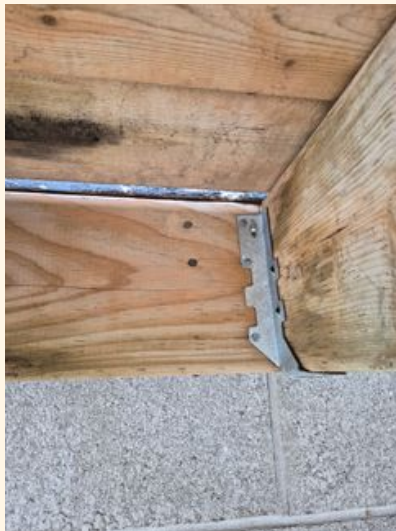
The deck ledger board has not been reliably connected to the house. This risks deck failure as the ledger attachment to the house can pull free. I recommend installing an attachment system that conforms to recommended minimum standards. The Town of Orangeville provides an excellent [Deck Construction Guide](#) for reference.

Hire a qualified deck contractor to further evaluate.

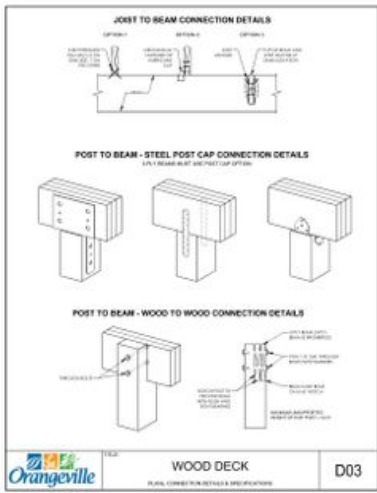
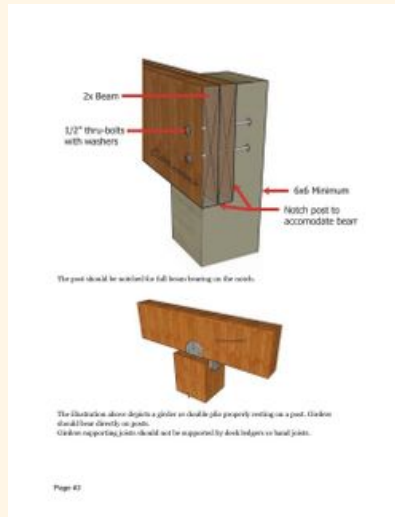
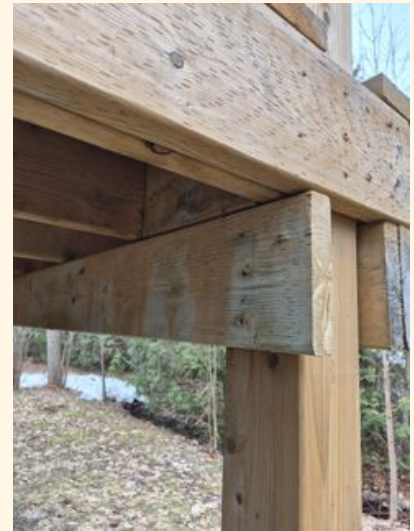
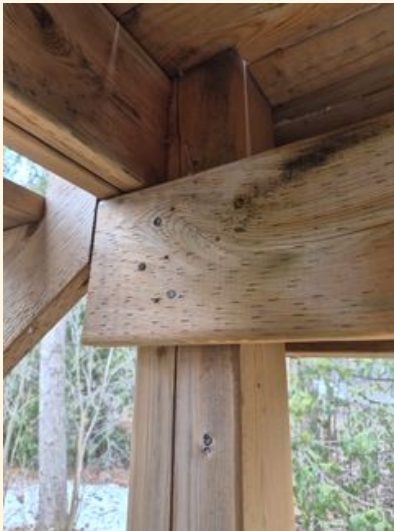
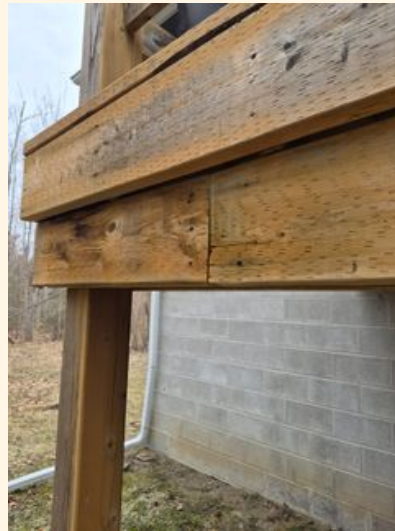
DPB-2 Wood Decks Porches and Balconies: The deck beams do not appear to be reliably connected to the posts. The beam is not bearing on the posts and nails were used for connection. When not done to normal standards it is difficult to predict how this connection will perform. The Town of Orangeville provides an excellent [Deck Construction Guide](#) for reference.

Hire a qualified deck contractor to further evaluate.

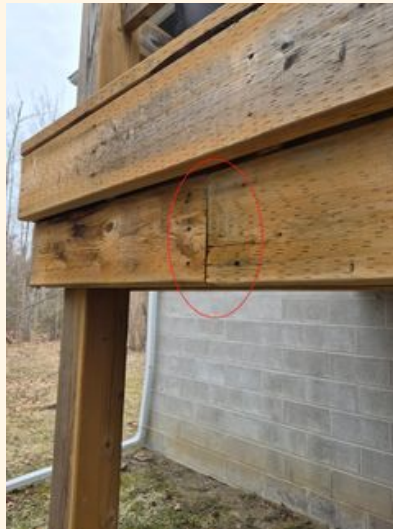
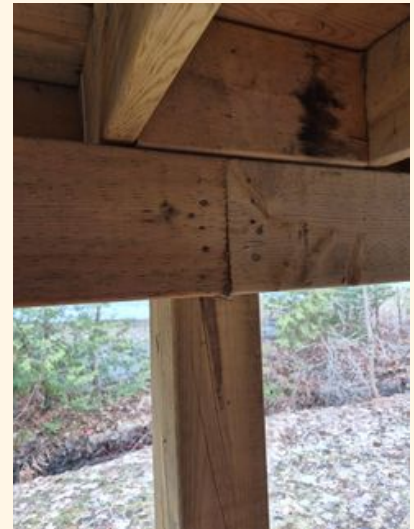
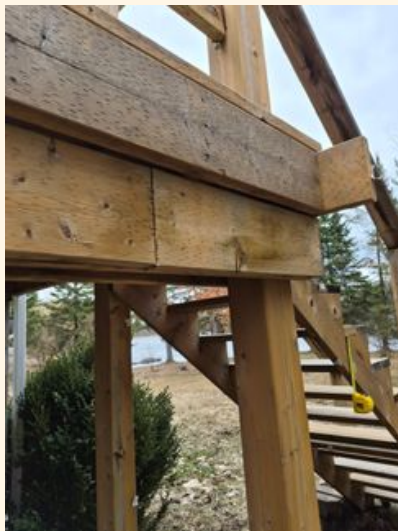
DPB-3 Wood Decks Porches and Balconies: Splices were observed in the deck girder spans. Girder members should be continuous or properly supported at posts; splices located between supports can weaken the span and reduce load-carrying capacity. This condition may compromise the structural performance of the deck.

Hire a qualified deck contractor to further evaluate.

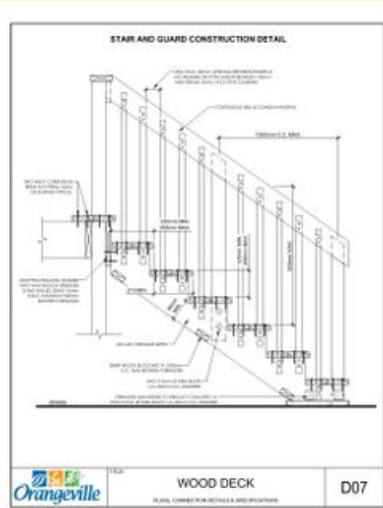
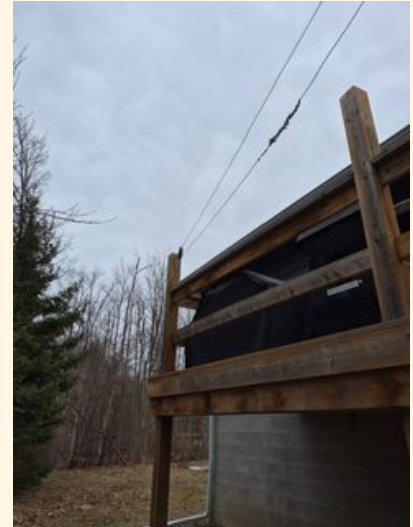
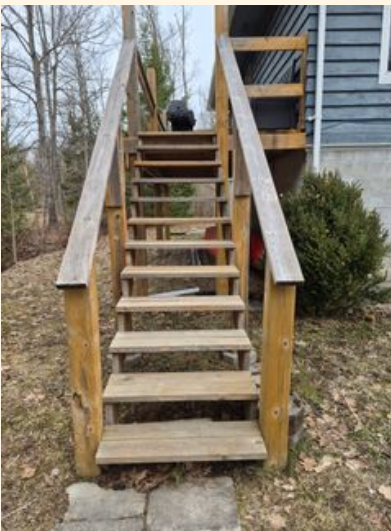
The openings for the deck guardrail are larger than the modern standard of 100mm. Caution should be used, especially around small children as they can often fit their head between this space of railing. The Town of Orangeville provides an excellent [Deck Construction Guide](#) for reference.

Hire a qualified deck contractor to further evaluate.

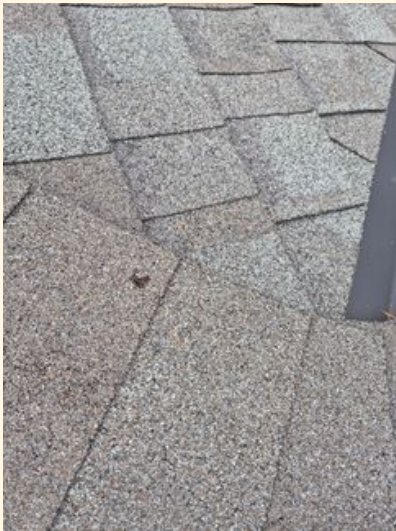
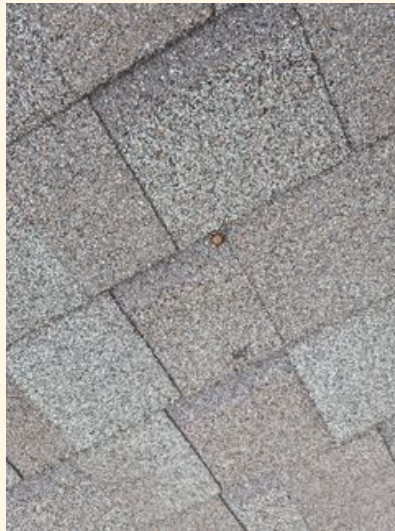
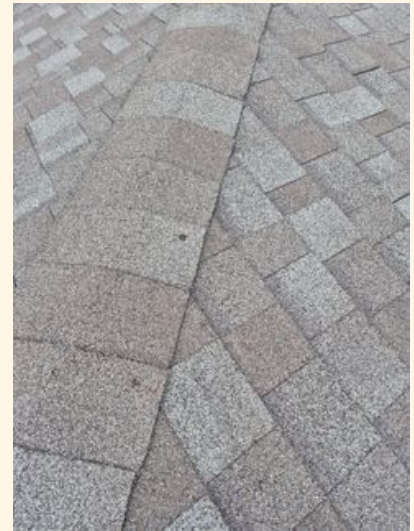
RCG-2 Roof Materials: All exposed fasteners on the roof should be sealed with mastic.

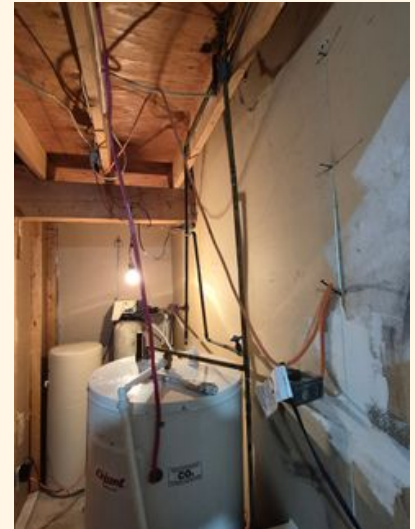
Have the electrical bonding system checked by a licensed electrician. Adequate bonding could not be verified at the main water pipe or the pipes by the water heater. This is an important safety feature to ensure safe control of stray voltage on metal systems in the house.

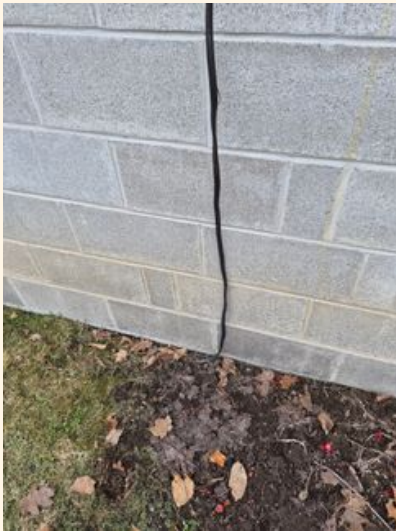
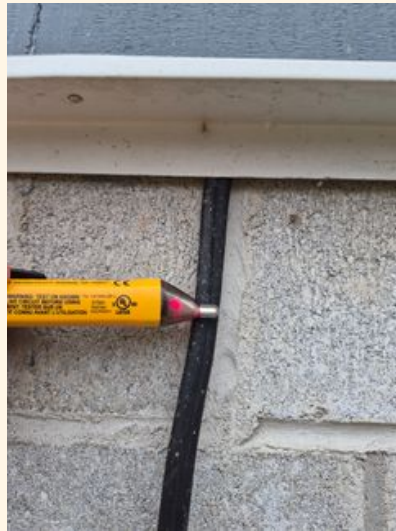
Surface-run cable wiring was noted during the inspection. The exposed non-metallic sheathed cable needs to be properly protected inside a conduit or raceway so that the cable is not subject to physical damage. This cable appears to be the feeder for the detached garage, though not visible for the entire run.

Hire a licensed electrician to further evaluate and repair.

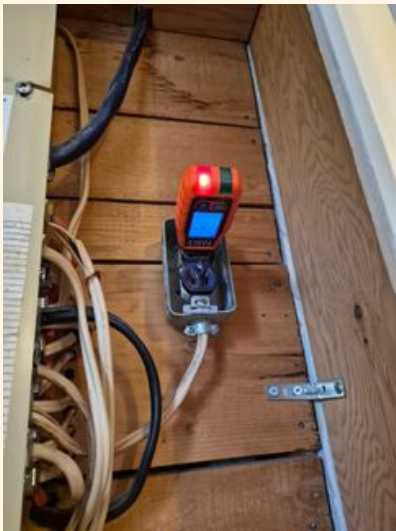
Receptacle next to electrical panel

Reverse polarity was noted at one of the electric receptacles. This is when the hot and the neutral wires have been wired backwards. This is a potential safety issue that should be corrected by a licensed electrical contractor.

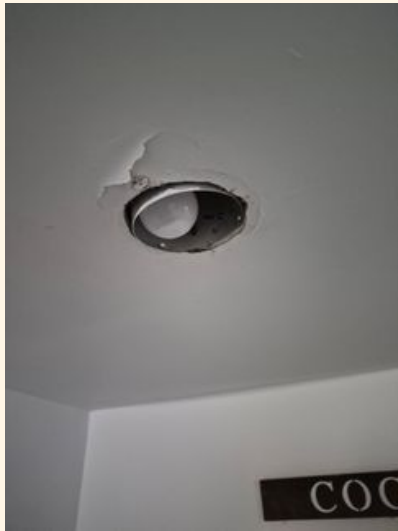
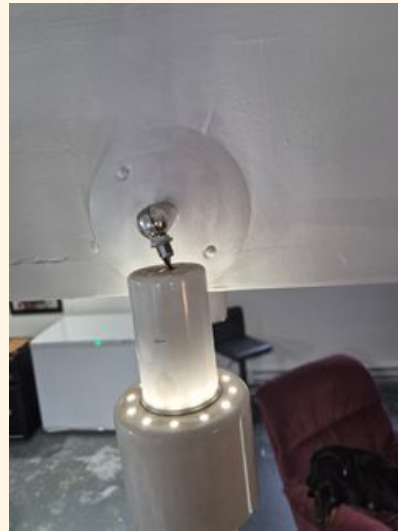
Damaged light fixtures were noted. Repair / replace as needed.

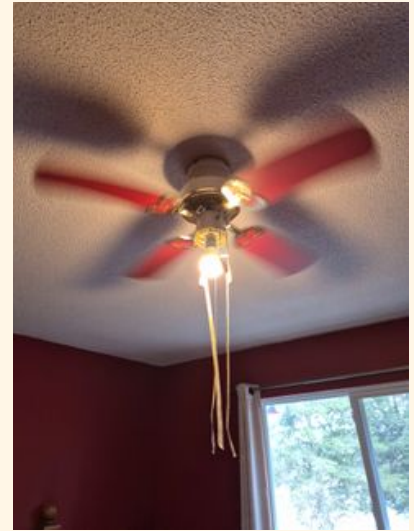
The ceiling fan in the bedroom is wobbling during operation at high speed. This can be a simple matter of balancing the fan blades, but it could also indicate an inadequately secured fan, which can present a safety hazard. Have this further evaluated and repaired as recommended by a qualified electrical contractor.

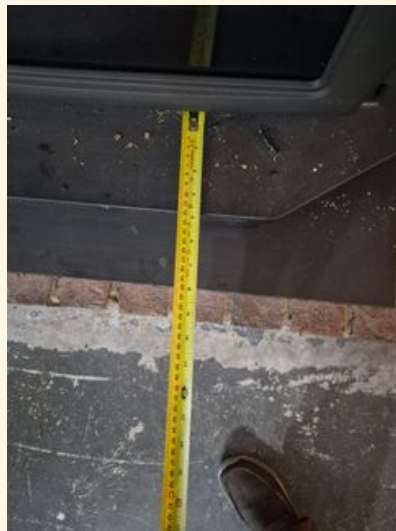
A wood stove has been inserted into a masonry firebox and the non-combustible hearth was not extended. This means the hearth is no longer an adequate size to protect the floor from hot embers. Have this further investigated and repaired by a qualified chimney sweep or mason. Provide an adequate non-combustible hearth for the front of the wood stove for operational safety.

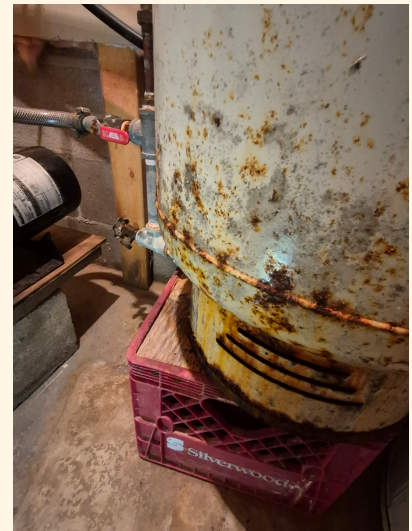
The well pressure tank is resting on an unstable makeshift support (milk crate) and shows visible rust.

Hire a qualified plumber to further evaluate.

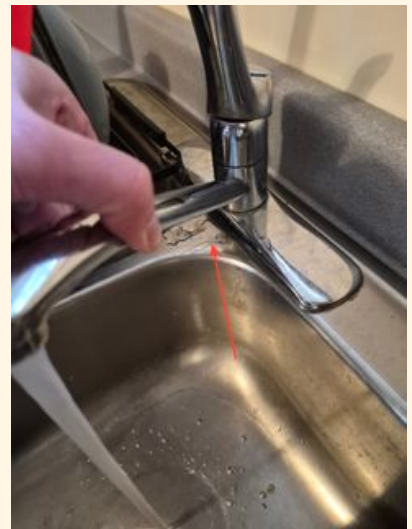
The kitchen sink faucet handle is leaking and needs to be repaired or replaced.

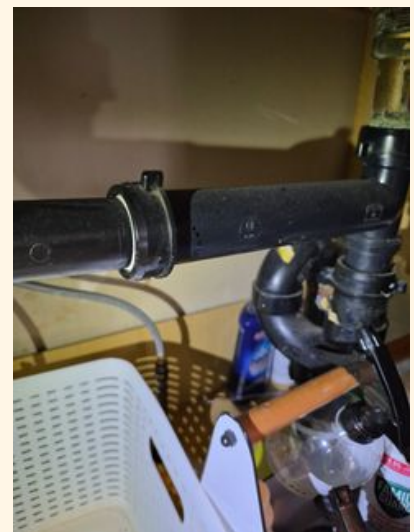
An S-trap was noted in the kitchen sink. This is an older style of waste piping that risks siphoning the trap and is no longer allowed. This should be further investigated and repaired by a licensed plumber to ensure reliable performance. Often an air admittance valve can be used to correct this configuration. Please note that trap siphoning could allow sewer gas to enter the house.

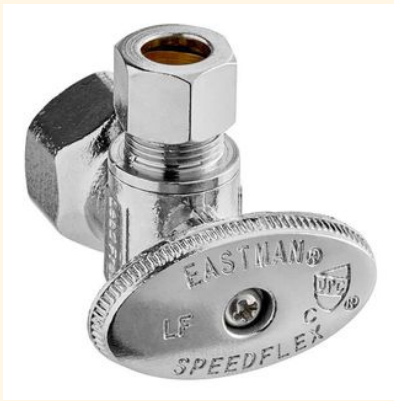
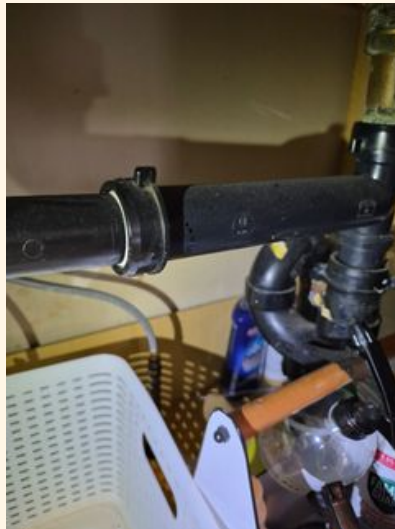
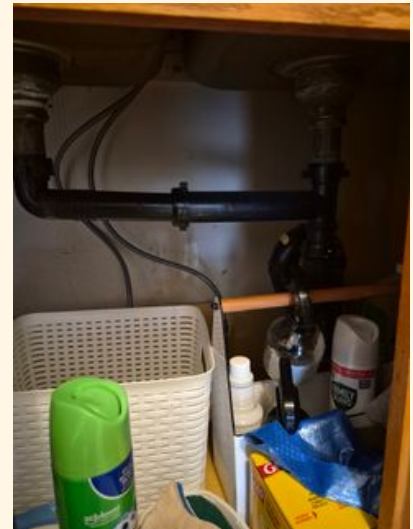
Isolation valves were not installed on the kitchen sink supply lines. Current plumbing standards require accessible shut-off valves at each fixture to allow localized servicing and to avoid shutting off water to the entire home during repairs.

Hire a qualified plumber to add proper isolation valves for future serviceability.

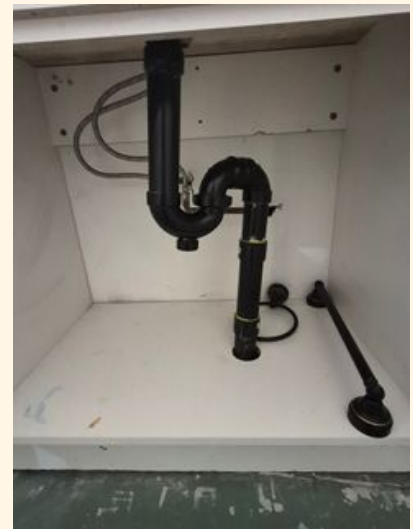
An S-trap was noted in the basement bathroom sink. This is an older style of waste piping that risks siphoning the trap and is no longer allowed. This should be further investigated and repaired by a licensed plumber to ensure reliable performance. Often an air admittance valve can be used to correct this configuration. Please note that trap siphoning could allow sewer gas to enter the house.

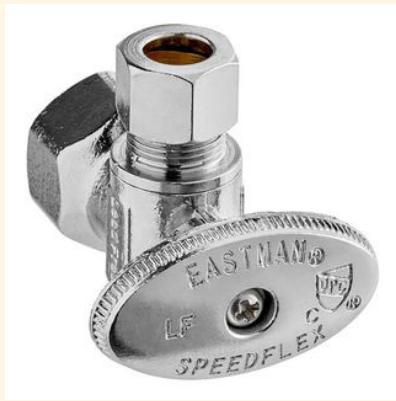
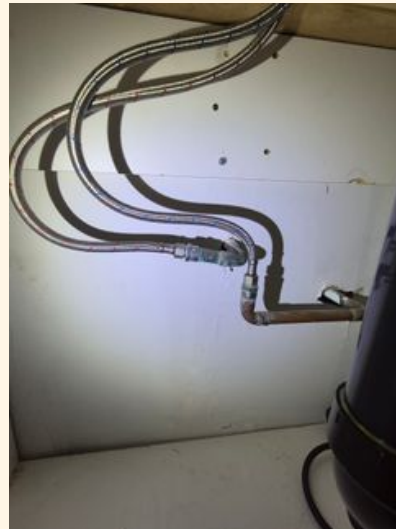
Isolation valves were not installed on the basement bathroom sink supply lines. Current plumbing standards require accessible shut-off valves at each fixture to allow localized servicing and to avoid shutting off water to the entire home during repairs.

Hire a qualified plumber to add proper isolation valves for future serviceability.

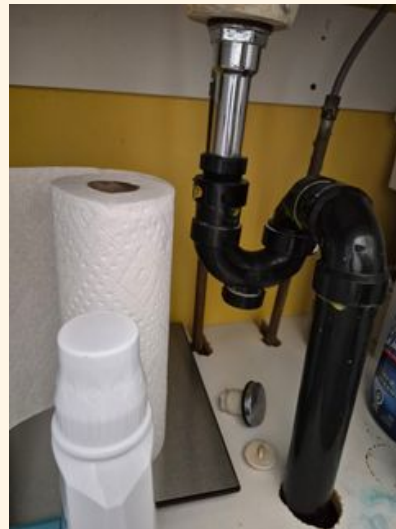
An [S-trap](#) was noted in the main bathroom sink. This is an older style of waste piping that risks siphoning the trap and is no longer allowed. This should be further investigated and repaired by a licensed plumber to ensure reliable performance. Often an air admittance valve can be used to correct this configuration. Please note that trap siphoning could allow sewer gas to enter the house.

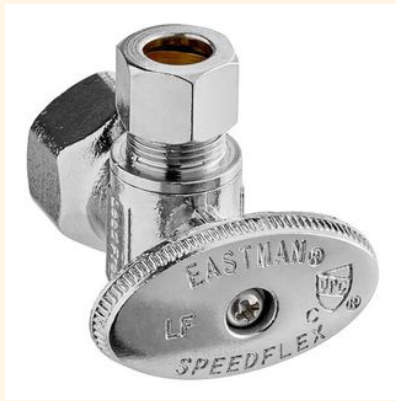
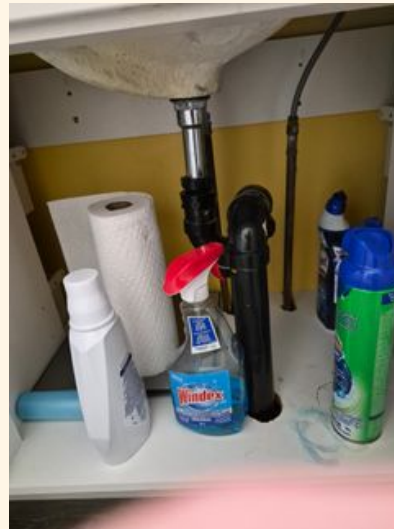
Isolation valves were not installed on the main bathroom sink supply lines. Current plumbing standards require accessible shut-off valves at each fixture to allow localized servicing and to avoid shutting off water to the entire home during repairs.

Hire a qualified plumber to add proper isolation valves for future serviceability.

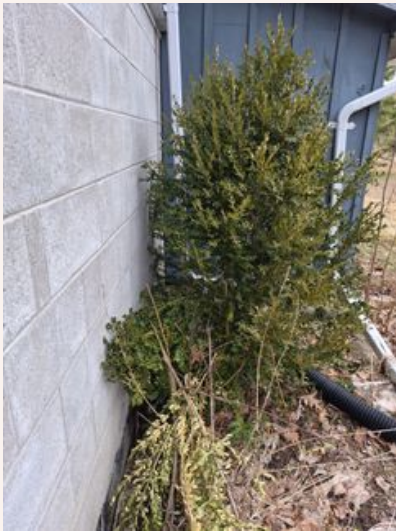
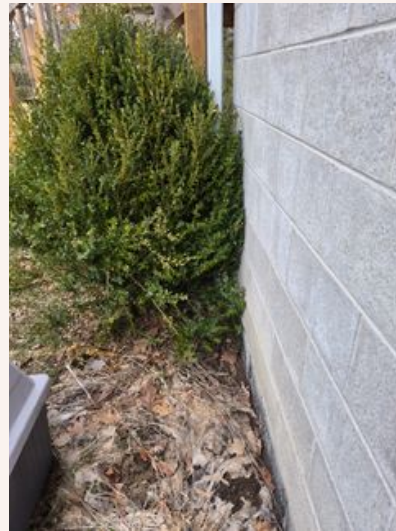
Pruning trees, branches, and vegetation away from the building is recommended. Where trees, branches, and large shrubs can provide rodent access to the roof, a minimum 6-foot clearance is recommended as many rodents can jump 6 feet. All vegetation, including smaller landscaping such as grasses, flowers, and shrubs should be kept 1 foot off the house to eliminate contact which could trap moisture against the building.

- Some of these mature shrubs are too close to the building.

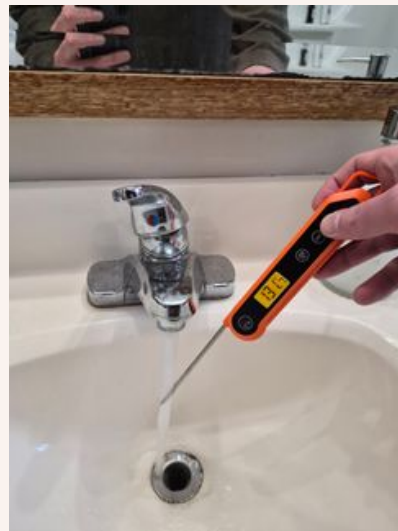
Testing of the plumbing system today, the water tested as too hot - 131 degrees F. This is a scald hazard. To prevent scalding, standards recommend indoor hot water temperatures do not exceed 120 degrees. There is some evidence that hot water temperatures should be greater than 130 degrees to prevent Legionnaires' disease from developing in the water heater. If this is a concern, you can heat the water in the tank to 140 degrees F and have a tempering valve installed at the hot water tank. Have this further evaluated and repaired by a licensed plumber, or simply turn down the temperature as desired to eliminate a scald hazard.

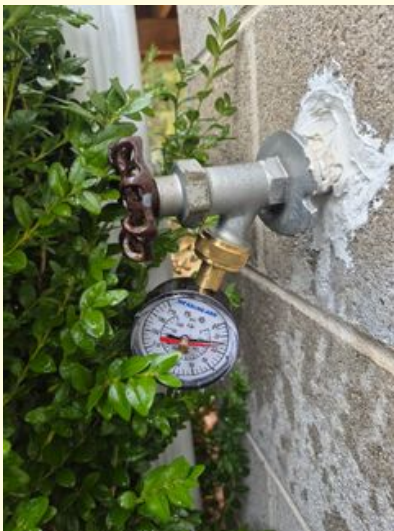
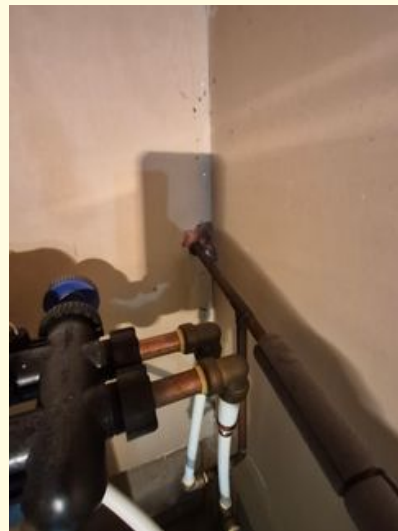
Older hose bibs were noted on this building. Updating the hose bibs is recommended. Modern hose bibs are typically "frost free," which are (arguably) more resistant to bursting in cold weather. They also have important vacuum breakers installed which can prevent water from your hoses backing into your water supply system. In the meantime, be sure to winterize your hose bibs during cold weather to prevent from freezing.

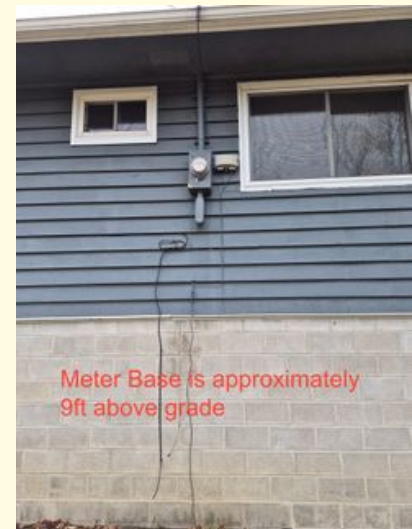
The electrical meter base is installed higher than the acceptable mounting range typically required by the local supply authority. Meter bases must be positioned so the meter remains safely and readily accessible from finished grade. Adjustment is recommended to ensure proper accessibility for service personnel.

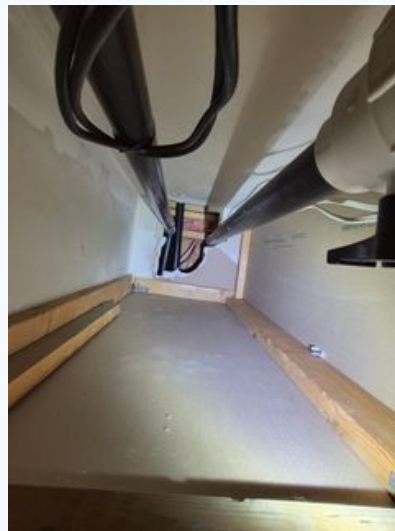
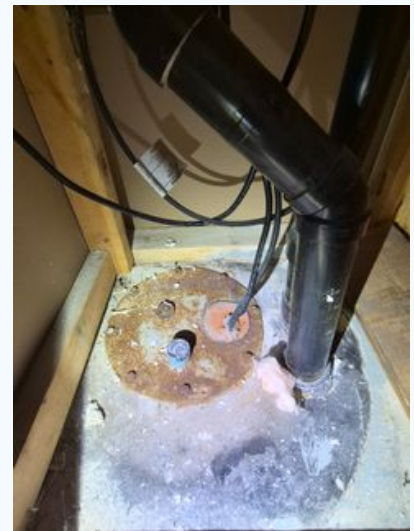
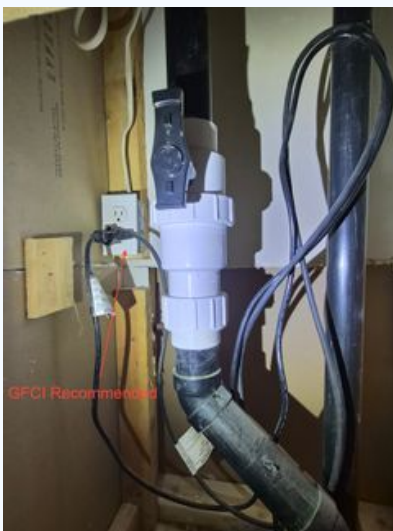
A sewage ejector system was noted serving the basement bathroom.

- Opening up the sewage ejector system is beyond the scope of a home inspection.
- I did not see a moisture alarm installed; these are recommended to alert you should the pump fail.

Have the sewage ejector system further evaluated and repaired / serviced as recommended by a qualified plumbing contractor.

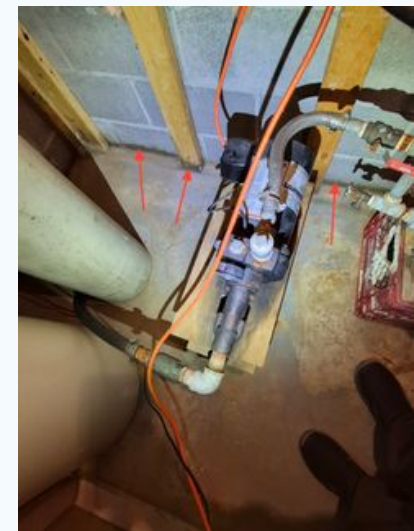
Water stains were noted on some of the basement finishes, indicating the basement has experienced prior moisture control problems. Inquire with the seller for any history of moisture intrusion and make all repairs to exterior drainage as recommended in this report, as this will reduce the chances of basement moisture. Additional basement waterproofing may be needed. The scope and urgency of additional repairs have a great deal to do with your plans and expectations for this space. The space was dry at the time of inspection, but conditions can change seasonally.

- This basement does not look well-suited to finishing without first waterproofing.

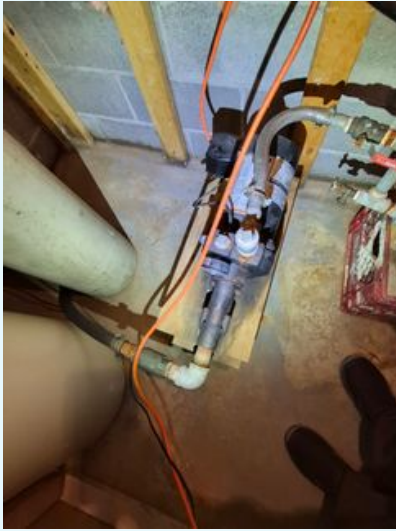
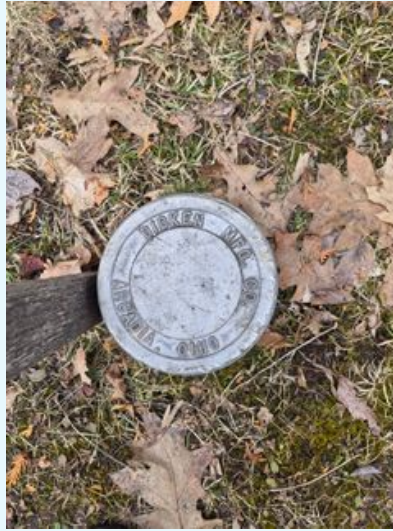
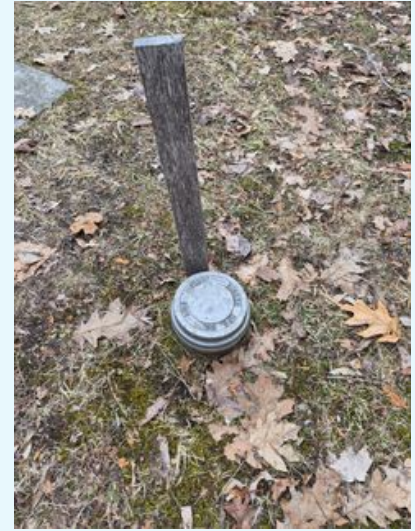
Well Head

Well equipment was noted for the water supply. Inspection of the well, water supply, and water quality are beyond the scope of this inspection.

I recommend hiring a well specialist to inspect and evaluate the well and well water. Well equipment: the pump and captive storage tank have limited service lives and often require updating on a 20-year schedule. There are other elements of a well system that should be evaluated as well, such as the well production, often tested in a draw-down test, water quality, and well depth.

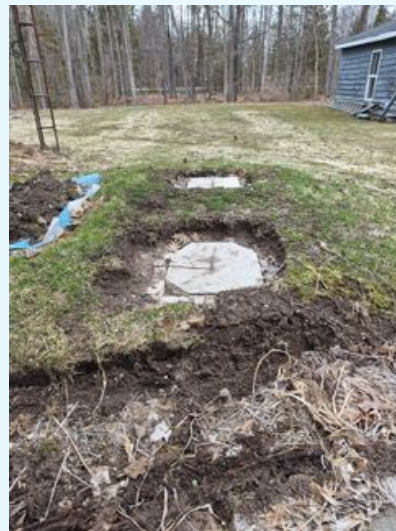
Based on visible components, this property appears to have a private on-site septic system. These are specialty systems and are excluded from this inspection. Comments in this report related to this system are made as a courtesy only and are not meant to be a substitute for a full evaluation by a qualified specialist. Generally, septic tanks should be pumped and inspected every 3 years. Depending on the type of system and municipal regulations, inspection and maintenance may be required more frequently, often annually. I recommend:

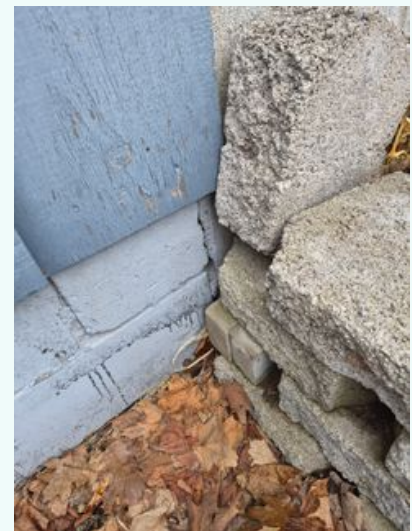
Small cracks were noted in the foundation. The purpose of the foundation is to connect the weight of the building to well-compacted soils below the house so that the house does not move or settle. Concrete cracking can indicate poorly compacted soils below the house which could require repair. ***It is not possible to determine or verify the cause of these cracks during a visual inspection.*** The easiest way to prevent ongoing settlement in buildings is by controlling roof runoff and site drainage to promote dry soils around the foundation; wet soils do not bear weight well. This will also help to prevent moisture problems. In my experience, small cracks like these are common in concrete foundations of this age.

- Monitor these cracks. If continued movement is noted, seek additional opinions from a structural engineer or qualified contractor to determine an accurate scope and urgency for repair.
