# Sample Report

This report is prepared exclusively for **Clients**  
Inspected On: **04-04-2026**

Outline Home Inspections  
(705) 879-6142

Dillon Koolhaas

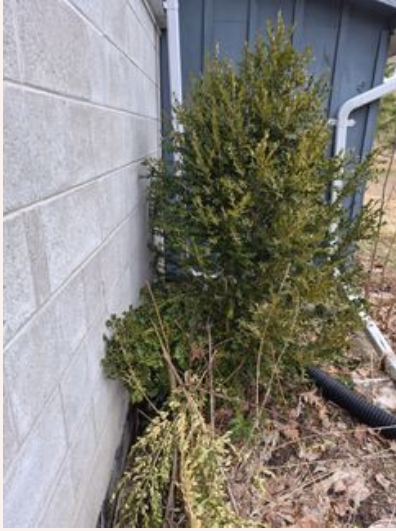
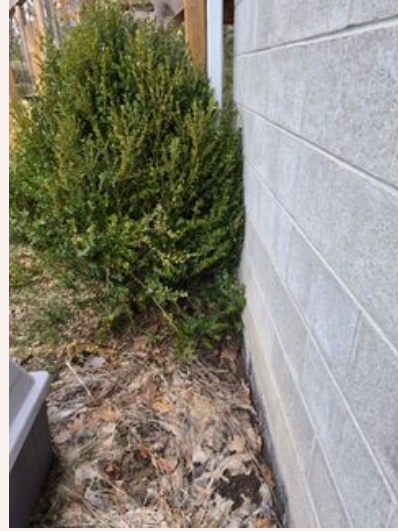
**(G1-3) Recommended Maintenance: TREE AND VEGETATION PRUNING**

- Some of these mature shrubs are too close to the building.

Pruning trees, branches, and vegetation away from the building is recommended. Where trees, branches, and large shrubs can provide rodent access to the roof, a minimum 6-foot clearance is recommended as many rodents can jump 6 feet. All vegetation, including smaller landscaping such as grasses, flowers, and shrubs should be kept 1 foot off the house to eliminate contact which could trap moisture against the building.

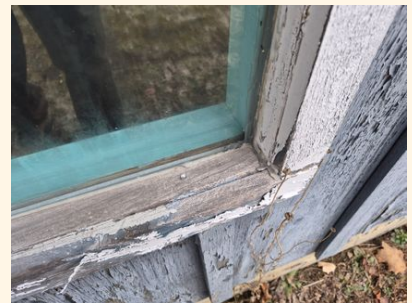
Many of the wood windows in this building are exposed to the weather and will require regular painting and sealing maintenance to preserve the windows and prevent decay. I checked the windows for wood decay and damage during inspection.

- Localized wood decay

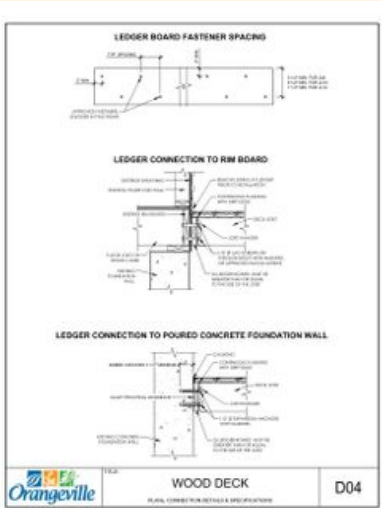
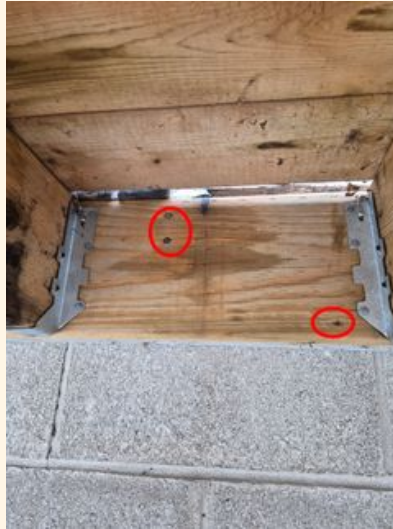
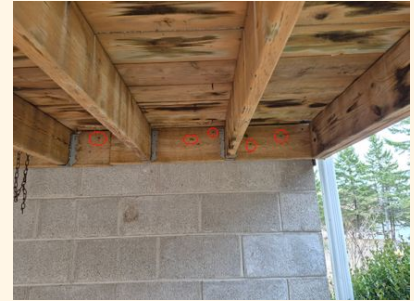
🔧 (DPB-1) Repair: **DECK LEDGER BOLTS NEEDED**

The deck ledger board has not been reliably connected to the house. This risks deck failure as the ledger attachment to the house can pull free. I recommend installing an attachment system that conforms to recommended minimum standards. The Town of Orangeville provides an excellent [Deck Construction Guide](#) for reference.

Hire a qualified deck contractor to further evaluate.

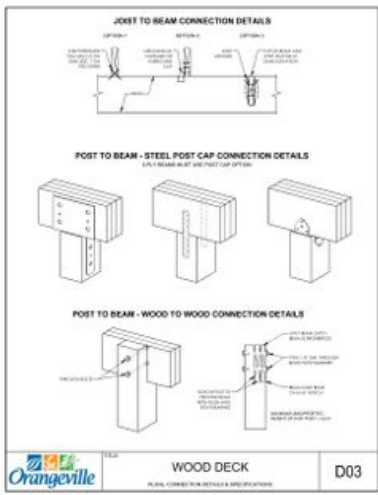
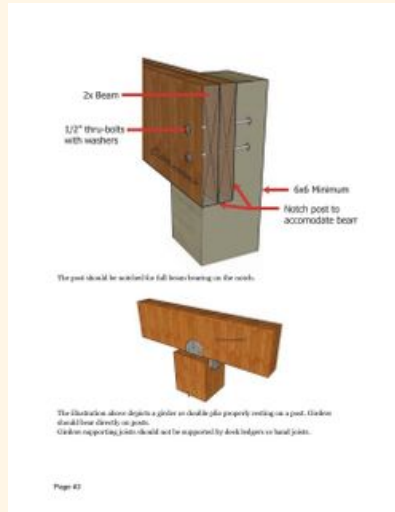
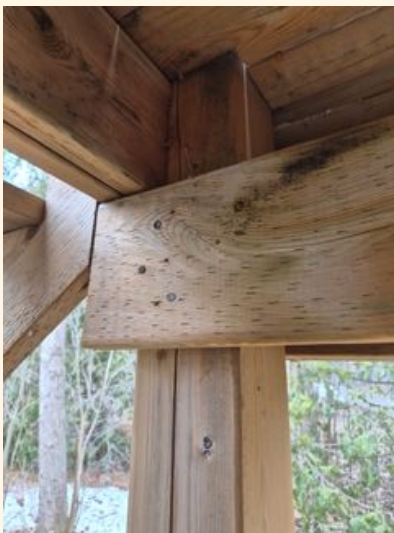
🔧 (DPB-2) Repair: The deck beams do not appear to be reliably connected to the posts. The beam is not bearing on the posts and nails were used for connection. When not done to normal standards it is difficult to predict how this connection will perform. The Town of Orangeville provides an excellent [Deck Construction Guide](#) for reference.

Hire a qualified deck contractor to further evaluate.

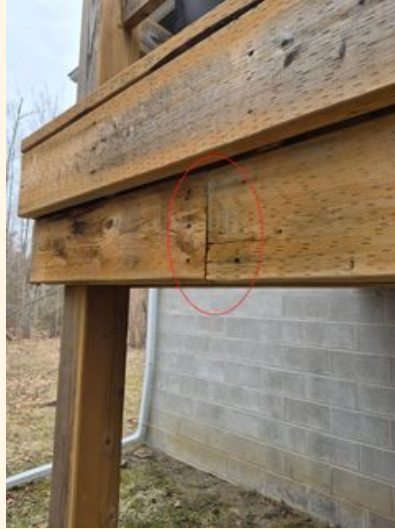
✂️ **(DPB-3) Repair:** Splices were observed in the deck girder spans. Girder members should be continuous or properly supported at posts; splices located between supports can weaken the span and reduce load-carrying capacity. This condition may compromise the structural performance of the deck.

The illustration above depicts a butt joint or splice improperly located within a girder span. Butt joints in a girder span are generally not permitted unless specially engineered. A butt joint or splice should be positioned to land at the posts.

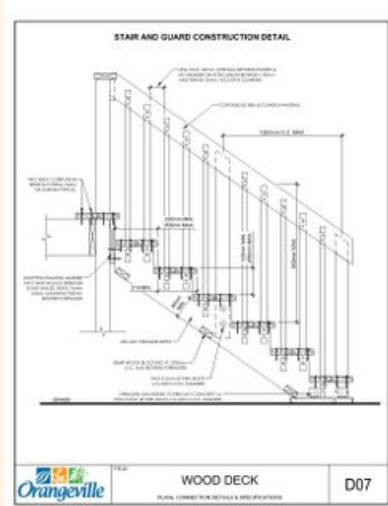
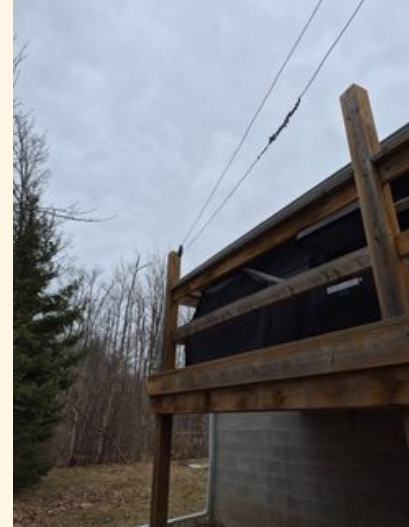
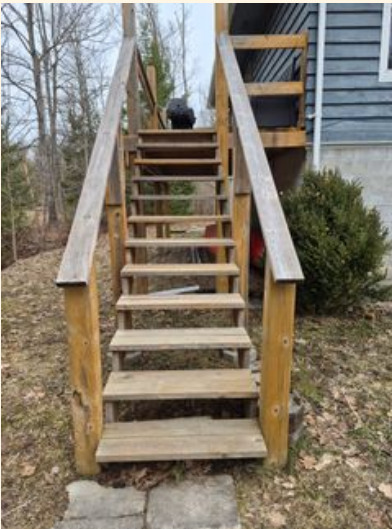
### (DPB-4) Repair: **LARGE OPENINGS FOR DECK GUARDRAIL**

The openings for the deck guardrail are larger than the modern standard of 100mm. Caution should be used, especially around small children as they can often fit their head between this space of railing. The Town of Orangeville provides an excellent [Deck Construction Guide](#) for reference.

Hire a qualified deck contractor to further evaluate.

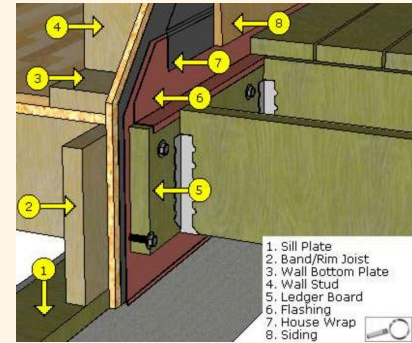
No flashings were noted between the deck ledger board and the home. This could allow water to get trapped between the deck and the house, causing rot and a conducive pest condition. This can be a difficult retrofit once the deck is constructed. No water damage was visible, but this could cause long term moisture control problems at the deck.

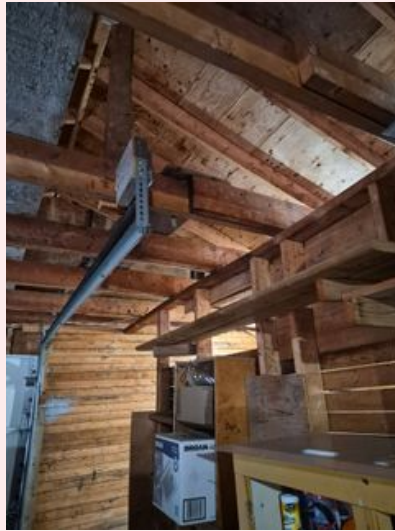
*poor garage door support (2)*

**⚠️ (G-1) Major Concern:** Extensive repairs are needed to the detached garage. Hire a licensed general contractor to further evaluate and repair. Examples of observations noted during inspection include:

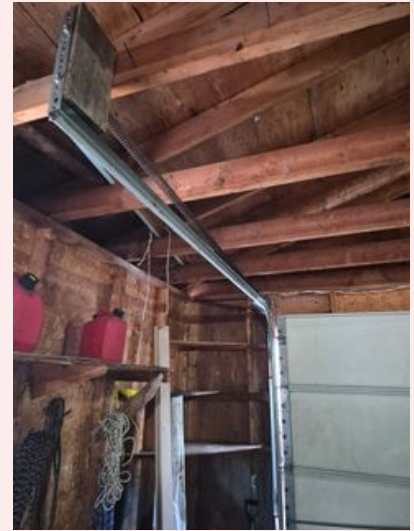
*poor garage door support*

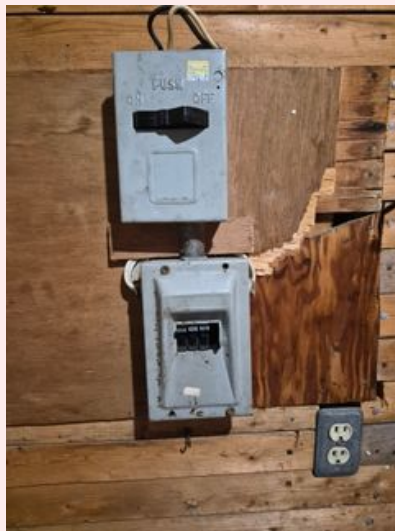
*Wrong screw type in subpanel, missing screws, missing breaker plates, unprotected cables in vulnerable area, poor mounting surface.*

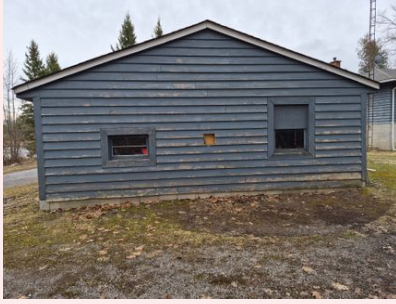
*Opening in siding, rotted siding*

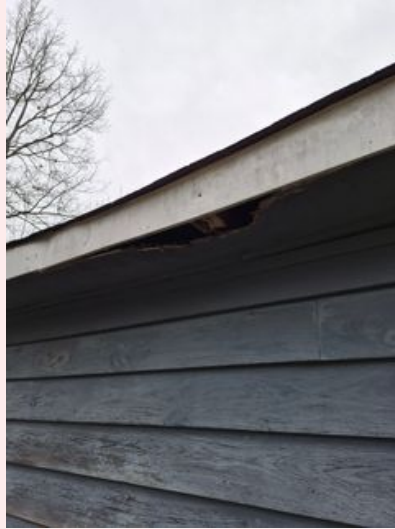
*large opening in damaged soffit*

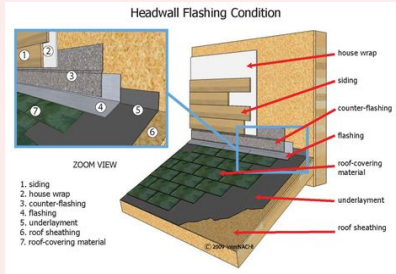
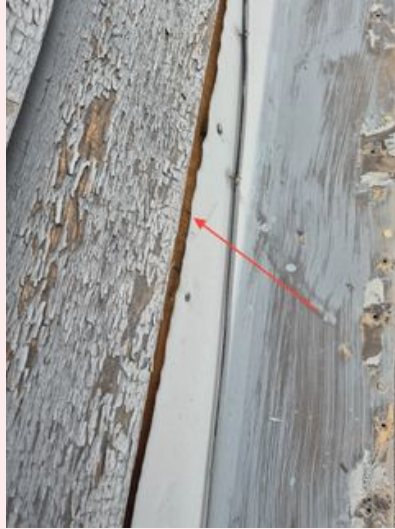
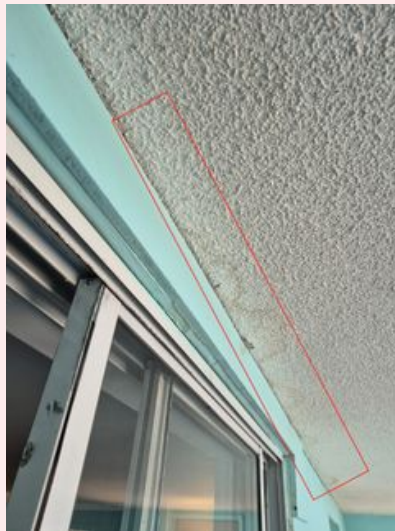
**⚠️ (RCG-1) Major Concern:** The headwall flashing has separated from the wall, creating a pathway for moisture to enter the structure. Signs of moisture damage are noted on the interior beneath this section. A qualified roofing contractor should repair or replace the flashing to restore proper weather protection.

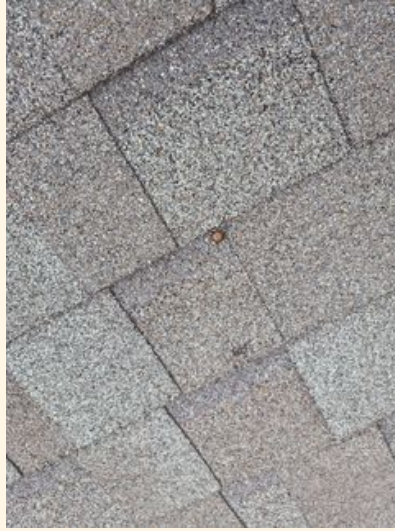
**🔧 (RCG-2) Repair:** All exposed fasteners on the roof should be sealed with mastic.

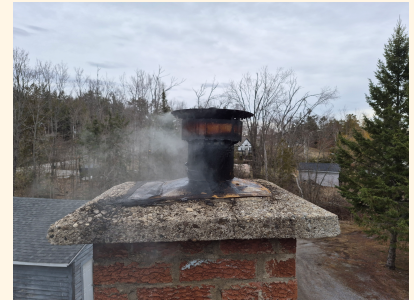
The chimney needs cleaned and repaired. Creosote is building up and can quickly choke a metal chimney cap. The masonry cap is cracked and spalling. Have this further investigated and repaired by a qualified mason or chimney sweep as recommended.

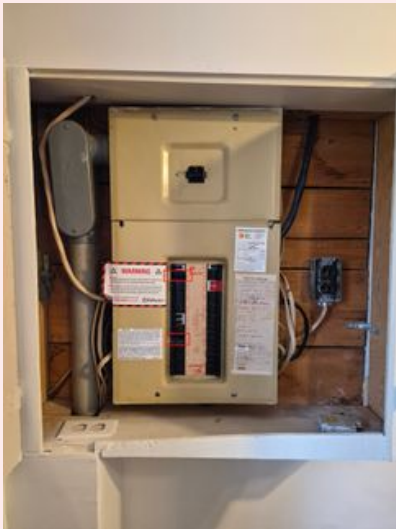
panel with a reputation for failing and malfunctioning breakers. Stab Lok electric panels are at greater risk of electrical fire and statistically less safe than any new electric panel. I recommend additional inspection of this electrical service by a licensed electrical contractor; updating this panel is recommended for improved reliability and safety. A number of observations were noted during the inspection:

*Openings in dead front cover*

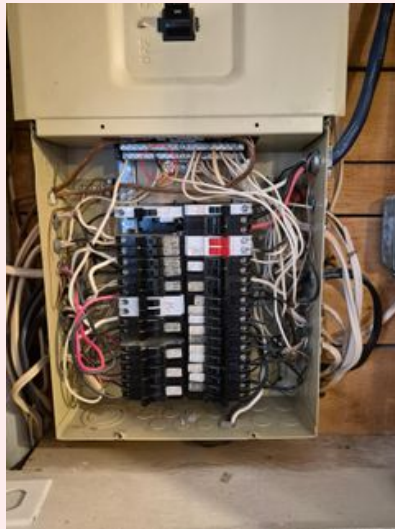
*burnt neutral wire*

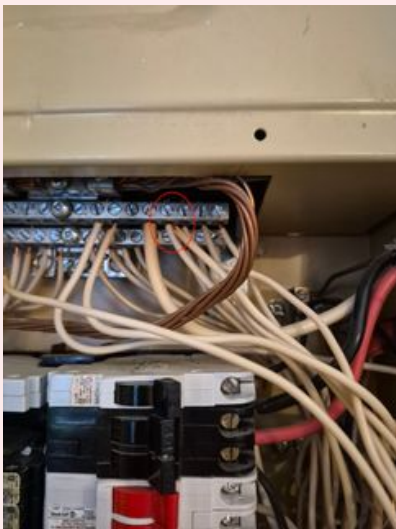
*double tapped neutral wires*

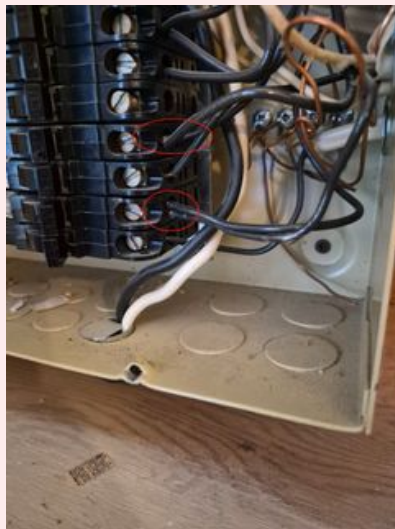
*double tapped hot wires*

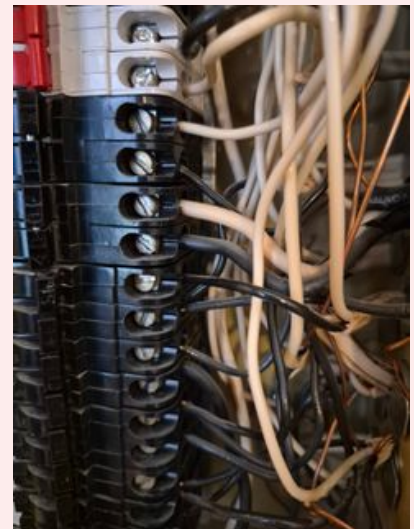
*double taps and unlabeled "neutral" hot wires*

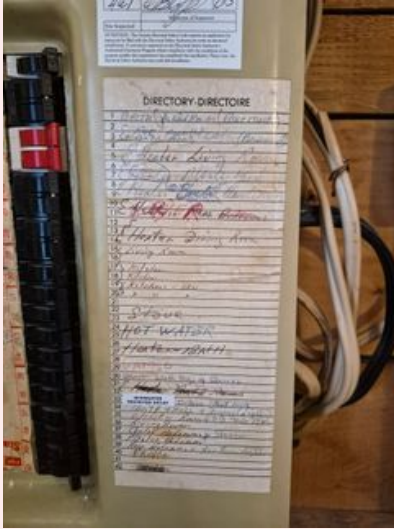
Poorly labelled panel

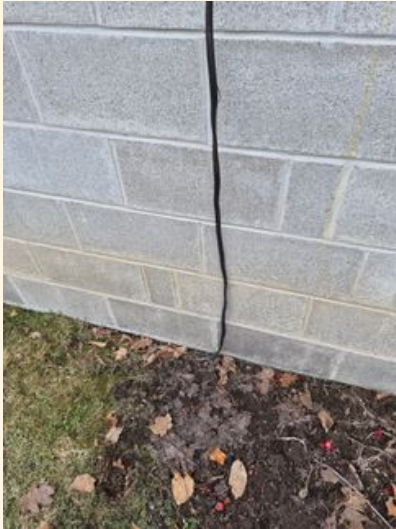
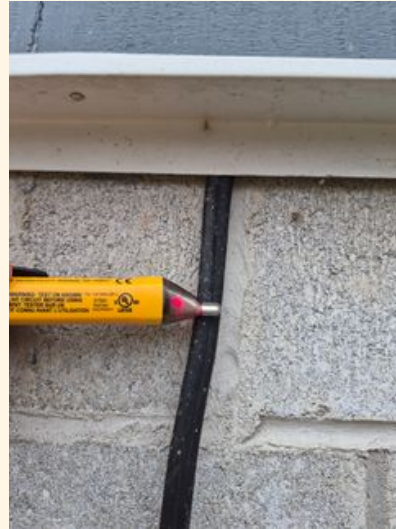
### WIRING REPAIRS NEEDED

Hire a licensed electrician to further evaluate and repair.

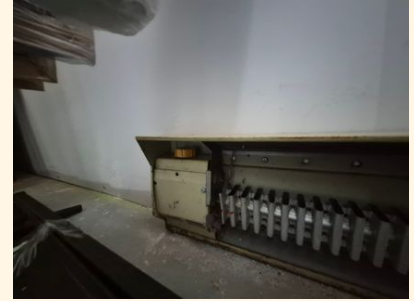
- Basement Bedroom (south wall)

Inoperative baseboard heaters were noted - they did not respond to testing. Hire a licensed electrician to repair or replace as needed. Locations noted during inspection include:

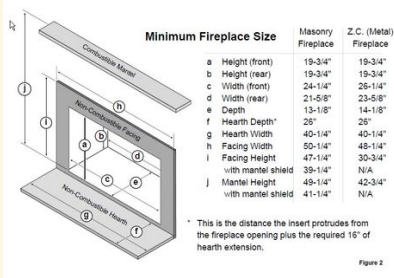
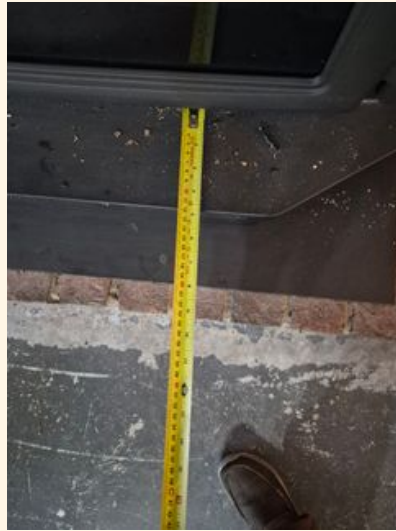
### 🔧 (HCFV-2) Repair: **INADEQUATE NON-COMBUSTIBLE HEARTH**

A wood stove has been inserted into a masonry firebox and the non-combustible hearth was not extended. This means the hearth is no longer an adequate size to protect the floor from hot embers. Have this further investigated and repaired by a qualified chimney sweep or mason. Provide an adequate non-combustible hearth for the front of the wood stove for operational safety.

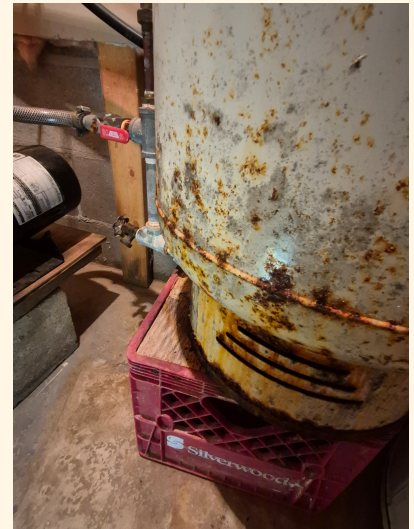
### (P-1) Repair:

The well pressure tank is resting on an unstable makeshift support (milk crate) and shows visible rust.

Hire a qualified plumber to further evaluate.

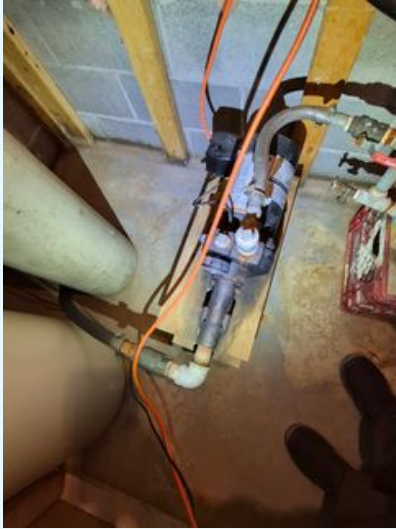
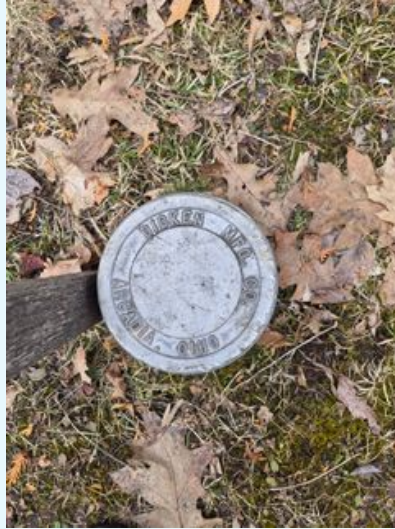
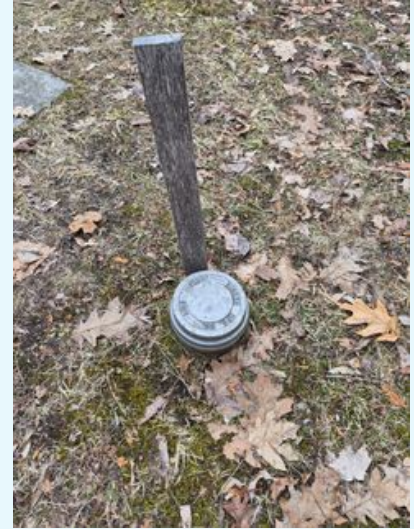
Well Head

Well equipment was noted for the water supply. Inspection of the well, water supply, and water quality are beyond the scope of this inspection.

I recommend hiring a well specialist to inspect and evaluate the well and well water. Well equipment: the pump and captive storage tank have limited service lives and often require updating on a 20-year schedule. There are other elements of a well system that should be evaluated as well, such as the well production, often tested in a draw-down test, water quality, and well depth.

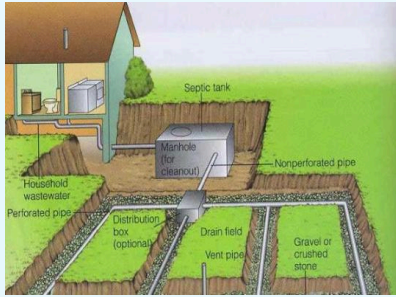
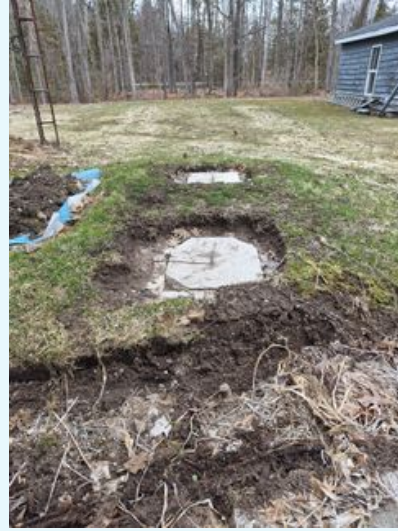
### **🏠 (P-5) Recommended Disclosure Items: ONSITE SEPTIC SYSTEM**

Based on visible components, this property appears to have a private on-site septic system. These are specialty systems and are excluded from this inspection. Comments in this report related to this system are made as a courtesy only and are not meant to be a substitute for a full evaluation by a qualified specialist. Generally, septic tanks should be pumped and inspected every 3 years. Depending on the type of system and municipal regulations, inspection and maintenance may be required more frequently, often annually. I recommend:

- Investigating any information about this system's maintenance and repair history
- Reviewing any documentation available for this system
- Learning inspection and maintenance requirements for this system
- Hire a qualified specialist to evaluate, perform maintenance and make repairs as needed

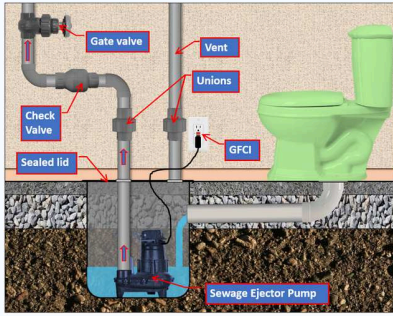
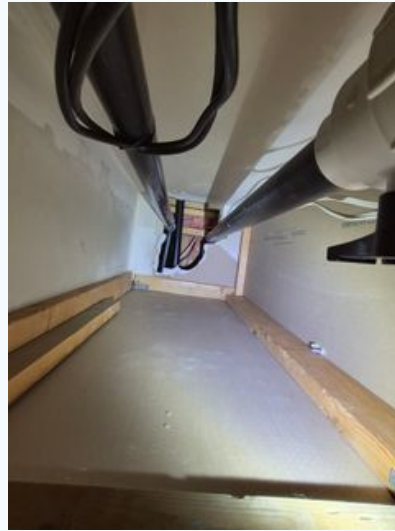
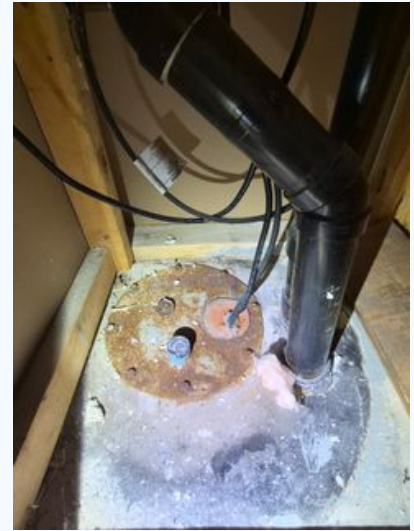
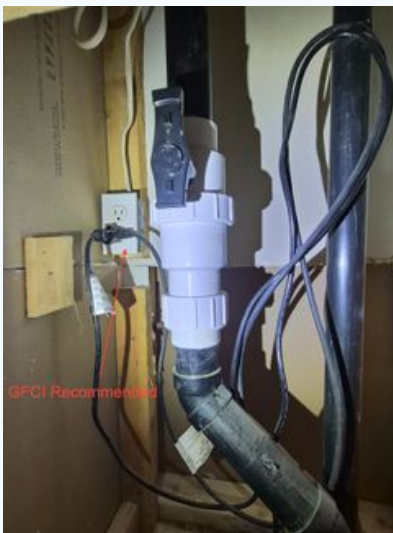
A sewage ejector system was noted serving the basement bathroom.

- Opening up the sewage ejector system is beyond the scope of a home inspection.
- I did not see a moisture alarm installed; these are recommended to alert you should the pump fail.

Have the sewage ejector system further evaluated and repaired / serviced as recommended by a qualified plumbing contractor.

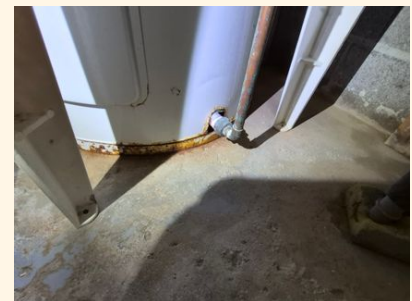
#### **NO DRAIN PAN FOR WATER HEATER**

No drain pan has been installed below the water heater here. A drain pan is recommended under water heaters that are located in finished spaces or where a leak could damage finishes. Where a pan does not already exist, the tricky part is providing a drain to the outside. A pan without a drain is often of limited benefit/protection. For improved protection from accidental water heater leaks and where a drain is difficult to install, consider a pan with a moisture alarm and a flood-safe device.

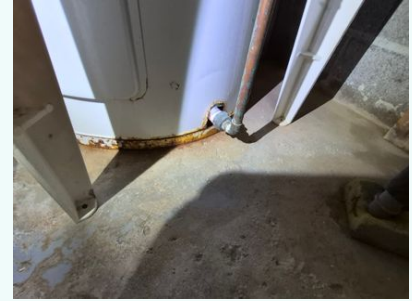
## (WH-2) Monitor: **RUST FORMING**

Rust is forming at the base of the water heater, suggesting a past leak or flooding. No active leakage was observed during the inspection. Monitor for any leaks or worsening of corrosion.

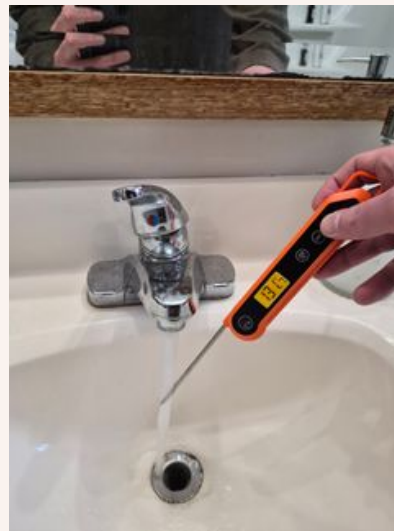
### (WH-3) Recommended Maintenance: **WATER TESTED HOT**

**Water Temperature Measured During Inspection: 132 Degrees F**

Testing of the plumbing system today, the water tested as too hot - 131 degrees F. This is a scald hazard. To prevent scalding, standards recommend indoor hot water temperatures do not exceed 120 degrees. There is some evidence that hot water temperatures should be greater than 130 degrees to prevent Legionnaires' disease from developing in the water heater. If this is a concern, you can heat the water in the tank to 140 degrees F and have a tempering valve installed at the hot water tank. Have this further evaluated and repaired by a licensed plumber, or simply turn down the temperature as desired to eliminate a scald hazard.

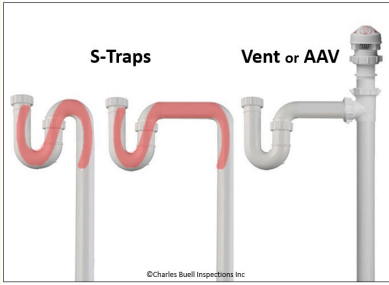
### (K-2) Repair: **S-TRAP CONFIGURATION NOTED**

An S-trap was noted in the kitchen sink. This is an older style of waste piping that risks siphoning the trap and is no longer allowed. This should be further investigated and repaired by a licensed plumber to ensure reliable performance. Often an air admittance valve can be used to correct this configuration. Please note that trap siphoning could allow sewer gas to enter the house.

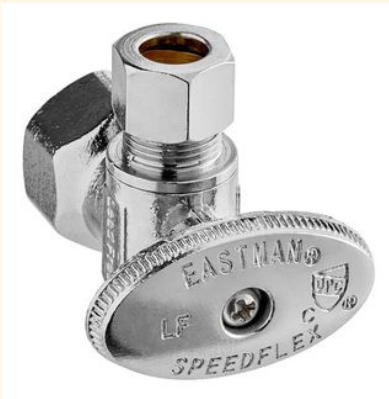
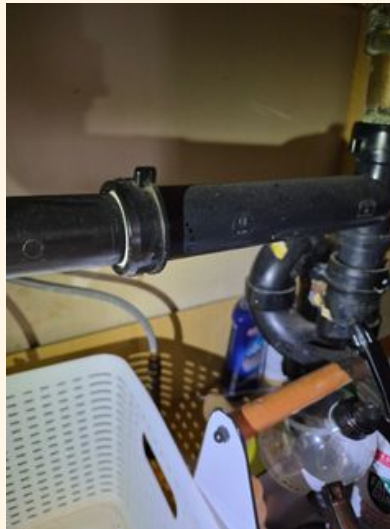
### 🔧 (K-3) Repair: **MISSING ISOLATION VALVES**

Isolation valves were not installed on the kitchen sink supply lines. Current plumbing standards require accessible shut-off valves at each fixture to allow localized servicing and to avoid shutting off water to the entire home during repairs.

Hire a qualified plumber to add proper isolation valves for future serviceability.

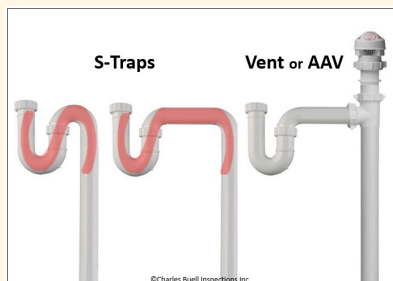
### 🔧 (BB-1) Repair: **S-TRAP CONFIGURATION NOTED**

An S-trap was noted in the basement bathroom sink. This is an older style of waste piping that risks siphoning the trap and is no longer allowed. This should be further investigated and repaired by a licensed plumber to ensure reliable performance. Often an air admittance valve can be used to correct this configuration. Please note that trap siphoning could allow sewer gas to enter the house.

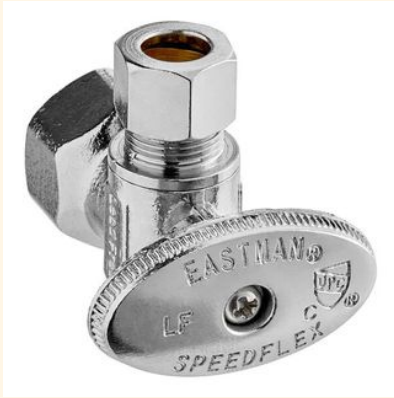
### 🔧 (BB-2) Repair: **MISSING ISOLATION VALVES**

Isolation valves were not installed on the basement bathroom sink supply lines. Current plumbing standards require accessible shut-off valves at each fixture to allow localized servicing and to avoid shutting off water to the entire home during repairs.

Hire a qualified plumber to add proper isolation valves for future serviceability.

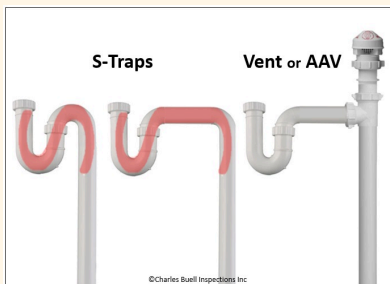
### 🔧 (MFB-1) Repair: **S-TRAP CONFIGURATION NOTED**

An [S-trap](#) was noted in the main bathroom sink. This is an older style of waste piping that risks siphoning the trap and is no longer allowed. This should be further investigated and repaired by a licensed plumber to ensure reliable performance. Often an air admittance valve can be used to correct this configuration. Please note that trap siphoning could allow sewer gas to enter the house.

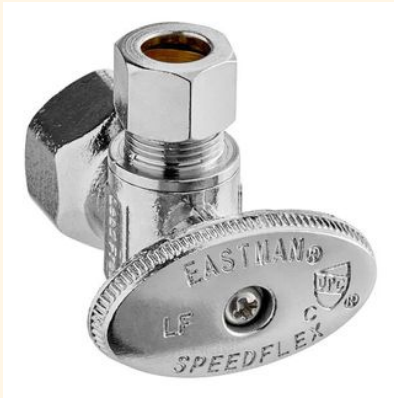
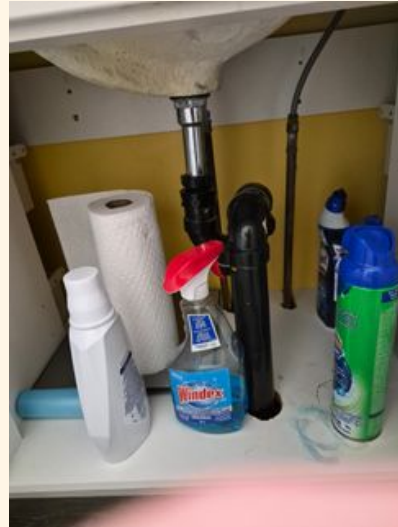
### 🔧 (MFB-2) Repair: **MISSING ISOLATION VALVES**

Isolation valves were not installed on the main bathroom sink supply lines. Current plumbing standards require accessible shut-off valves at each fixture to allow localized servicing and to avoid shutting off water to the entire home during repairs.

Hire a qualified plumber to add proper isolation valves for future serviceability.

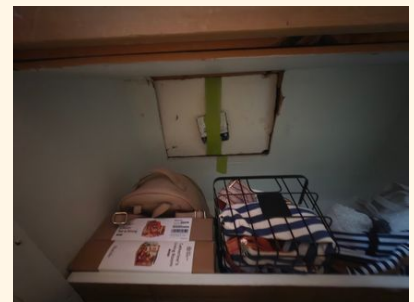
### 🔧 (A-1) Repair: **SMALL ATTIC ACCESS POINT**

The attic access hatch is too small and cannot be entered. Standards for attic access size is 30"/22" to provide access to this space to work and make repairs/improvements.

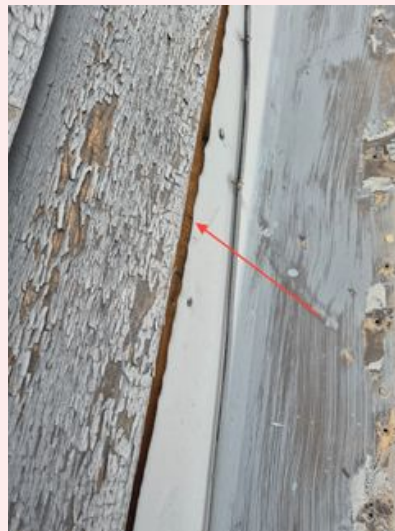
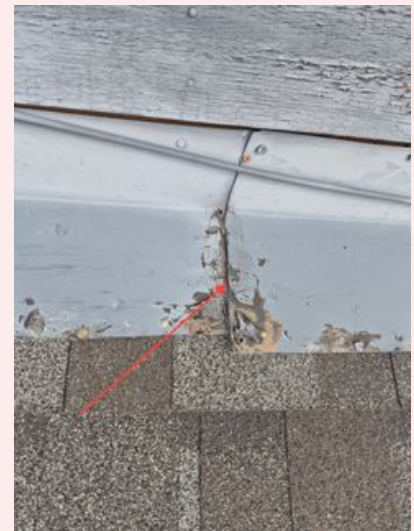
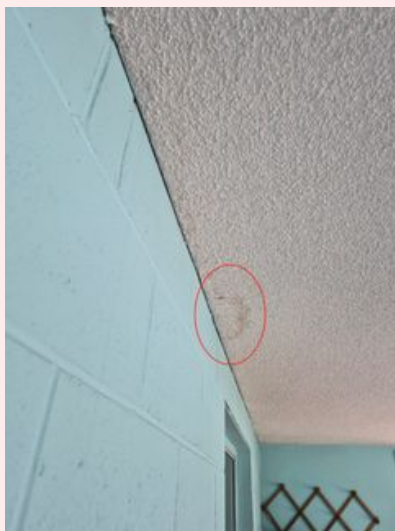
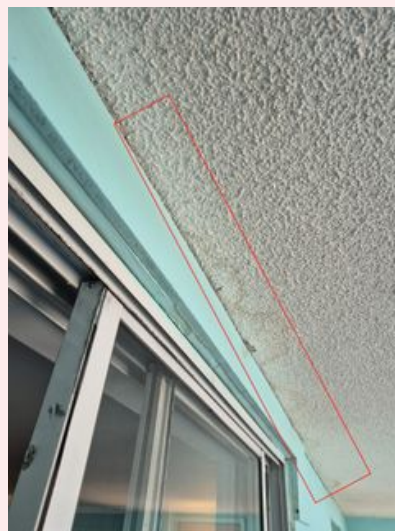
**⚠️ RCG-1 Roof Materials:** The headwall flashing has separated from the wall, creating a pathway for moisture to enter the structure. Signs of moisture damage are noted on the interior beneath this section. A qualified roofing contractor should repair or replace the flashing to restore proper weather protection.

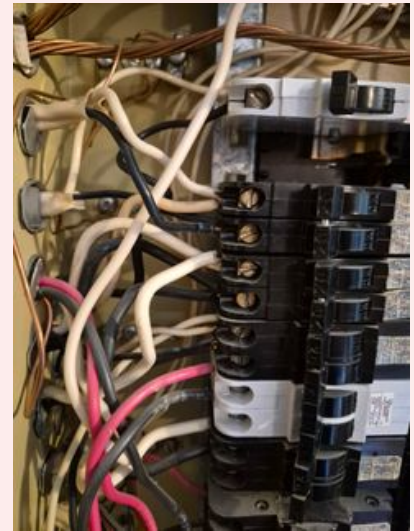
A [Federal Pioneer Electric Stab Lok](#) brand electric panel was noted. This is an obsolete brand of panel with a reputation for failing and malfunctioning breakers. Stab Lok electric panels are at greater risk of electrical fire and statistically less safe than any new electric panel. I recommend additional inspection of this electrical service by a licensed electrical contractor; updating this panel is recommended for improved reliability and safety. A number of observations were noted during the inspection:

*burnt neutral wire*

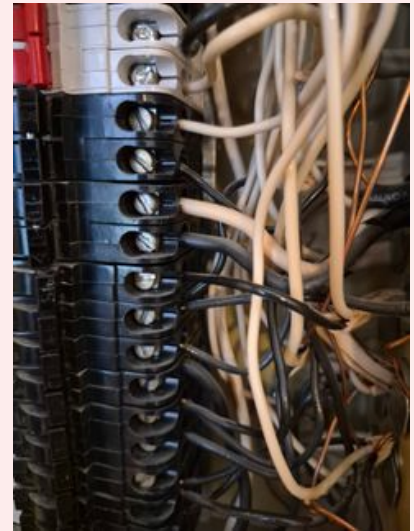
*double tapped hot wires*

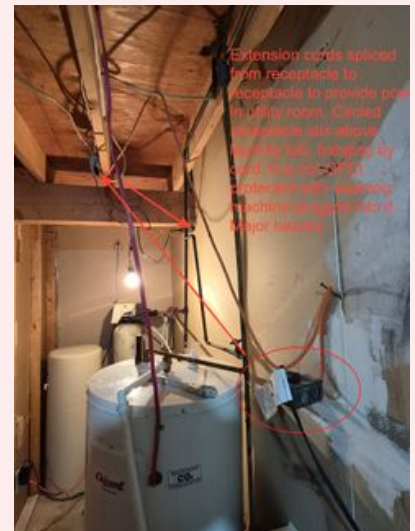
**⚠ EDF-1 Branch Wiring:  
WIRING REPAIRS NEEDED**

Several repairs are needed to the wiring system. Unconventional wiring and receptacles are noted in the attached image. Non-standard cables and splicing techniques are being used.

- The types of wiring repairs found today indicate work was likely done here by someone who was not a licensed electrician - it would be wise to check for any permit records of history
- The extent and types of repair items noted during inspection suggest there will be additional concealed repair work here.

Hire a licensed electrical contractor to further evaluate and repair.

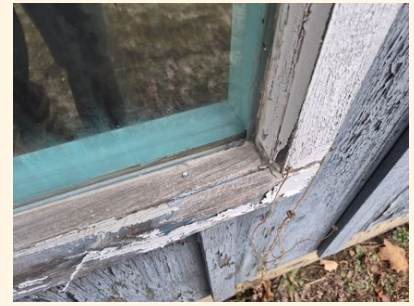
Many of the wood windows in this building are exposed to the weather and will require regular painting and sealing maintenance to preserve the windows and prevent decay. I checked the windows for wood decay and damage during inspection.

- Localized wood decay

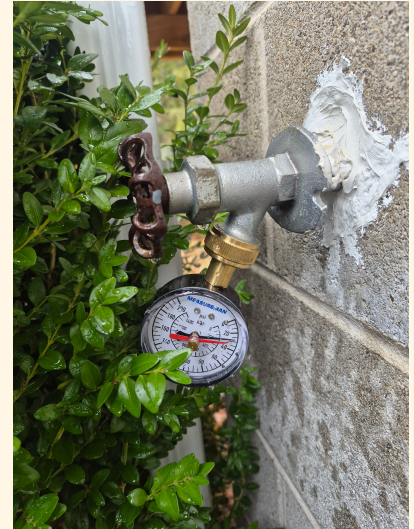
#### LOW WATER PRESSURE NOTED

Low water pressure was noted. A bare minimum of 30 PSI is recommended to serve the home. Often, well systems require servicing and repair to recharge storage tanks and even update pump systems. I recommend having the well system further evaluated and repaired as recommended by a well specialist.

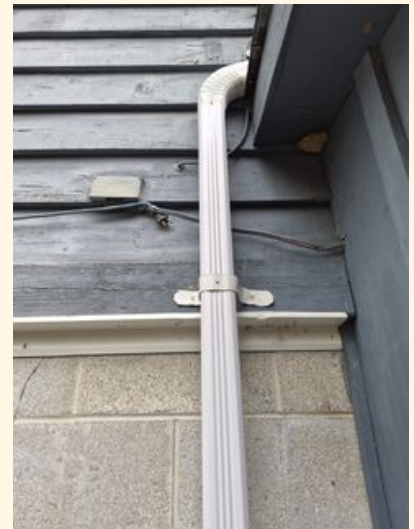
The exterior receptacle has been installed at a height that prevents safe and convenient access from ground level. Additionally, non-metallic sheathed cable was observed running exposed along the exterior wall surface. This wiring method is not suitable for outdoor exposure and is vulnerable to physical and environmental damage. Recommend evaluation by an electrical contractor.

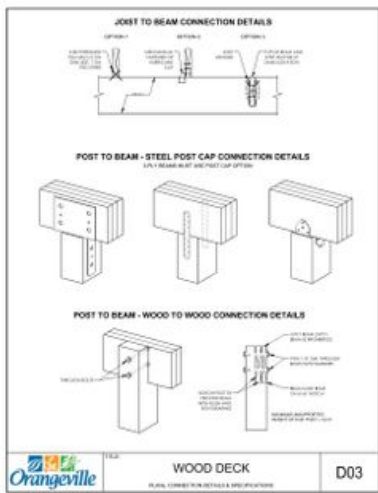
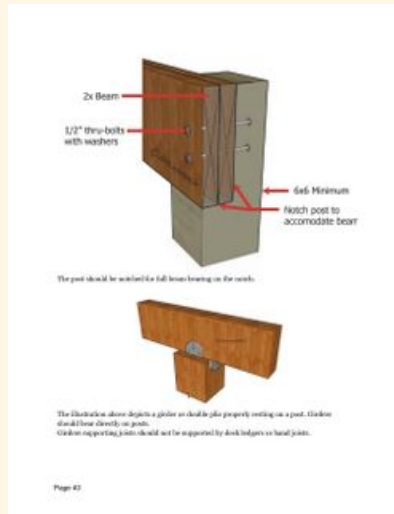
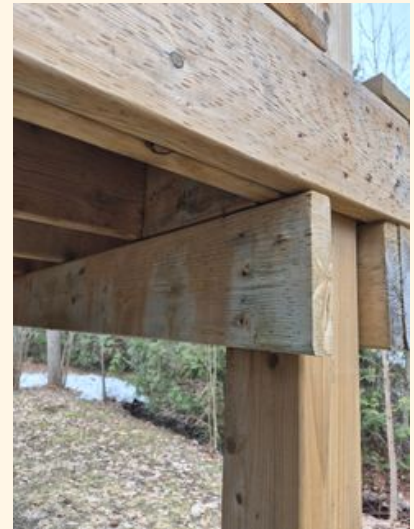
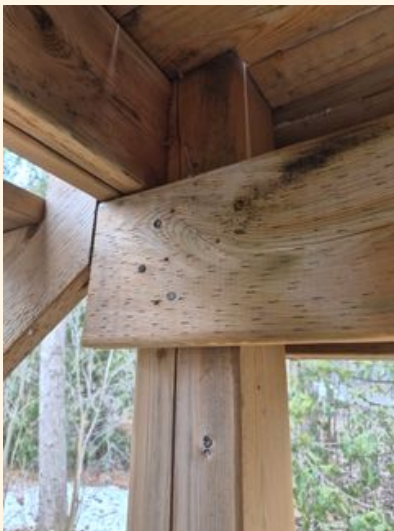
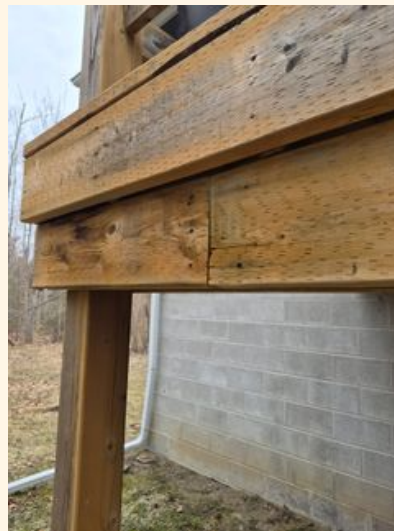
**DPB-2 Wood Decks Porches and Balconies:** The deck beams do not appear to be reliably connected to the posts. The beam is not bearing on the posts and nails were used for connection. When not done to normal standards it is difficult to predict how this connection will perform. The Town of Orangeville provides an excellent [Deck Construction Guide](#) for reference.

Hire a qualified deck contractor to further evaluate.

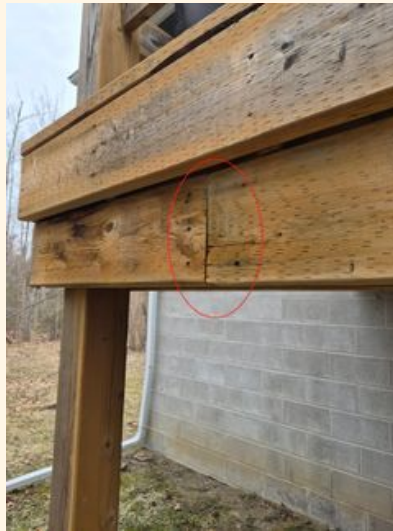
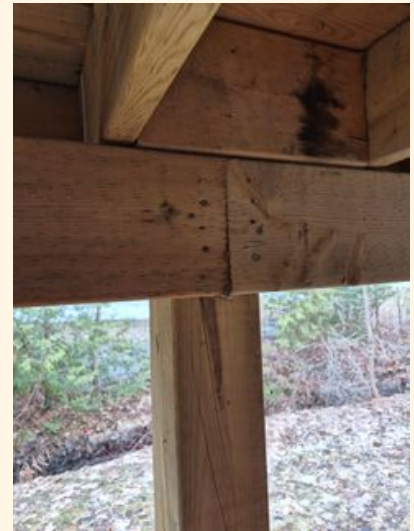
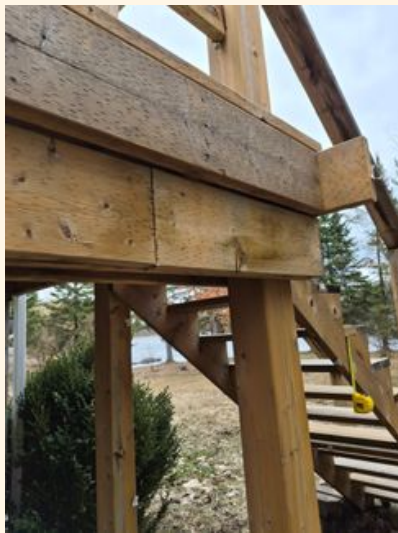
**DPB-3 Wood Decks Porches and Balconies:** Splices were observed in the deck girder spans. Girder members should be continuous or properly supported at posts; splices located between supports can weaken the span and reduce load-carrying capacity. This condition may compromise the structural performance of the deck.

The illustration above depicts a butt joint or splice improperly located within a girder span. Butt joints in a girder span are generally not permitted unless specially engineered. A butt joint or splice should be positioned to land at the posts.

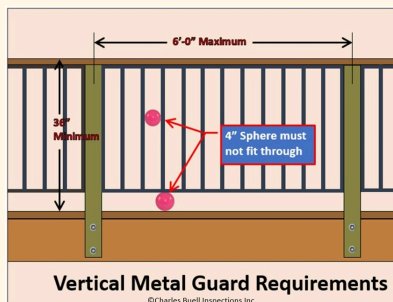
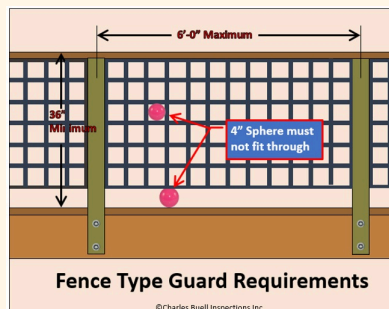
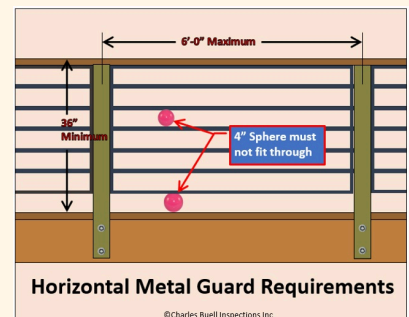
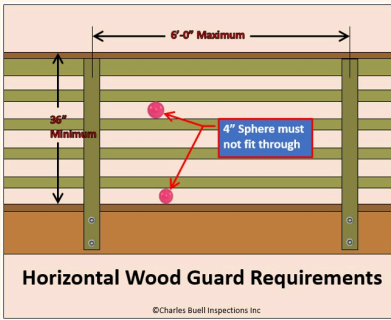
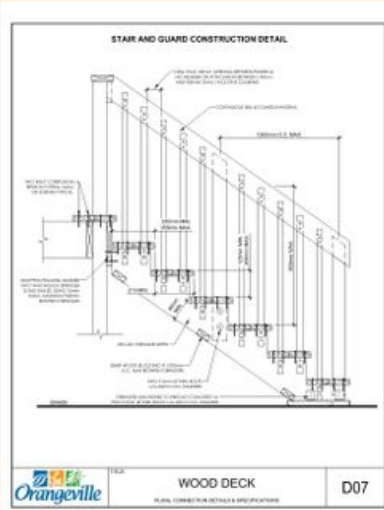
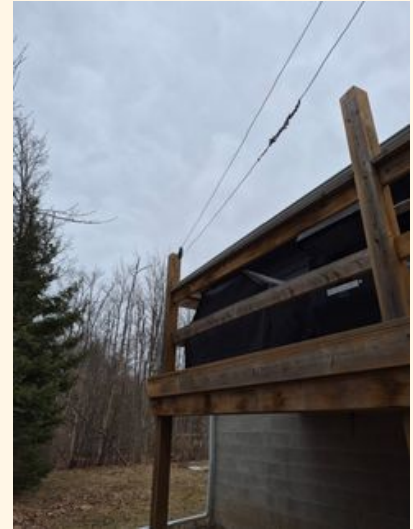
### **DPB-4 Wood Decks Porches and Balconies: LARGE OPENINGS FOR DECK GUARDRAIL**

The openings for the deck guardrail are larger than the modern standard of 100mm. Caution should be used, especially around small children as they can often fit their head between this space of railing. The Town of Orangeville provides an excellent [Deck Construction Guide](#) for reference.

Hire a qualified deck contractor to further evaluate.

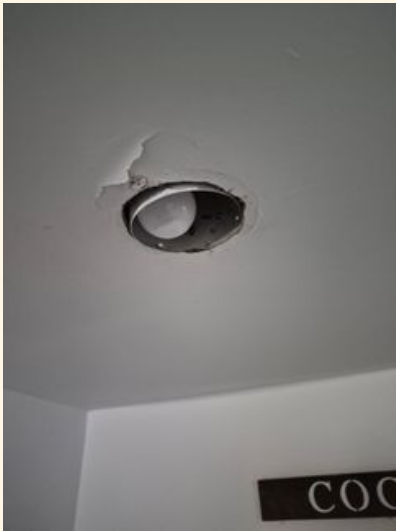
### 🔧 EDF-4 Receptacles and Fixtures: **DAMAGED LIGHT FIXTURES**

Damaged light fixtures were noted. Repair / replace as needed.

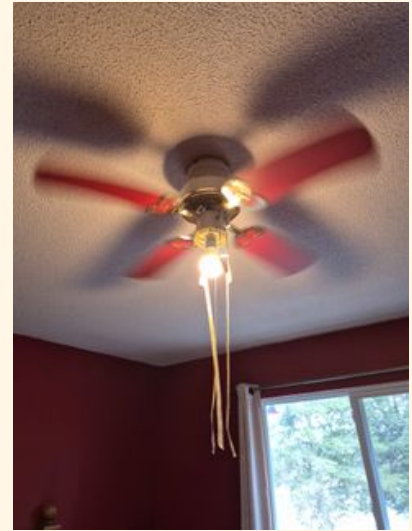
The ceiling fan in the bedroom is wobbling during operation at high speed. This can be a simple matter of balancing the fan blades, but it could also indicate an inadequately secured fan, which can present a safety hazard. Have this further evaluated and repaired as recommended by a qualified electrical contractor.

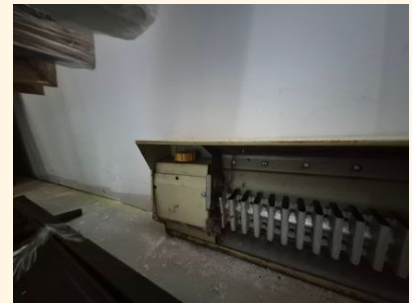
### 🔧 HCFV-1 Heating Systems: **INOPERATIVE BASEBOARD HEATERS**

Inoperative baseboard heaters were noted - they did not respond to testing. Hire a licensed electrician to repair or replace as needed. Locations noted during inspection include:

- Basement Bedroom (south wall)

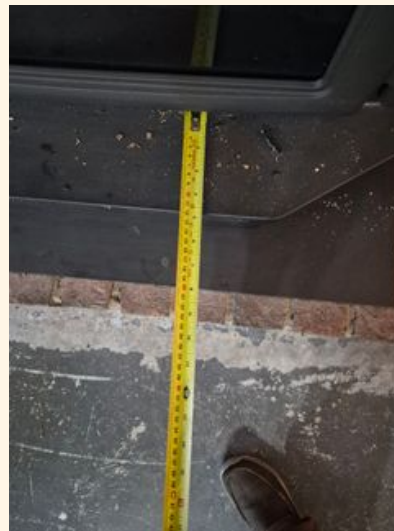
### 🔧 HCFV-2 Solid Fuel Fireplaces: **INADEQUATE NON-COMBUSTIBLE HEARTH**

A wood stove has been inserted into a masonry firebox and the non-combustible hearth was not extended. This means the hearth is no longer an adequate size to protect the floor from hot embers. Have this further investigated and repaired by a qualified chimney sweep or mason. Provide an adequate non-combustible hearth for the front of the wood stove for operational safety.

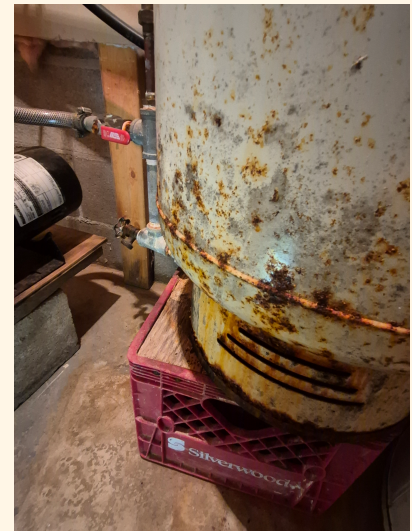
The well pressure tank is resting on an unstable makeshift support (milk crate) and shows visible rust.

Hire a qualified plumber to further evaluate.

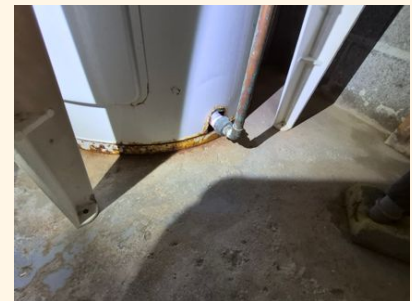
#### **NO DRAIN PAN FOR WATER HEATER**

No drain pan has been installed below the water heater here. A drain pan is recommended under water heaters that are located in finished spaces or where a leak could damage finishes. Where a pan does not already exist, the tricky part is providing a drain to the outside. A pan without a drain is often of limited benefit/protection. For improved protection from accidental water heater leaks and where a drain is difficult to install, consider a pan with a moisture alarm and a flood-safe device.

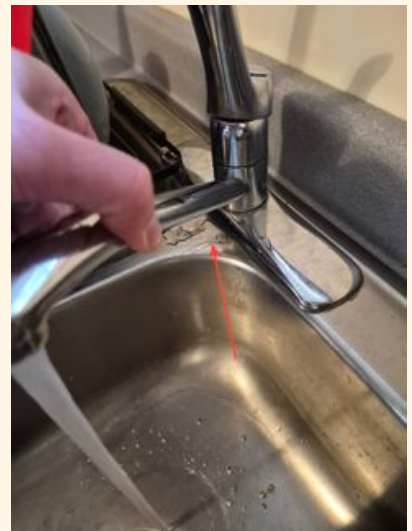
### **K-1 Sinks and Faucets:** **KITCHEN SINK FAUCET IS LEAKING**

The kitchen sink faucet handle is leaking and needs to be repaired or replaced.

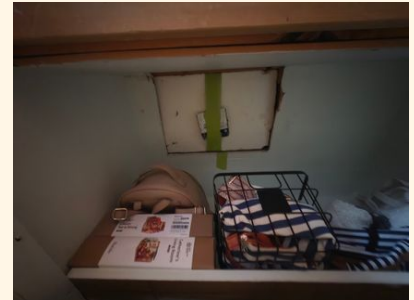
**A-1 Attic Access:**  
**SMALL ATTIC ACCESS POINT**

The attic access hatch is too small and cannot be entered. Standards for attic access size is 30"/22" to provide access to this space to work and make repairs/improvements.

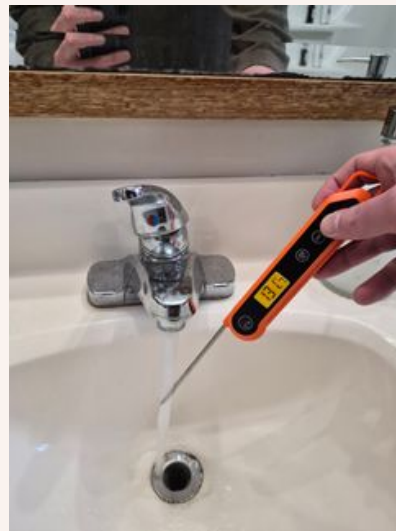
Testing of the plumbing system today, the water tested as too hot - 131 degrees F. This is a scald hazard. To prevent scalding, standards recommend indoor hot water temperatures do not exceed 120 degrees. There is some evidence that hot water temperatures should be greater than 130 degrees to prevent Legionnaires' disease from developing in the water heater. If this is a concern, you can heat the water in the tank to 140 degrees F and have a tempering valve installed at the hot water tank. Have this further evaluated and repaired by a licensed plumber, or simply turn down the temperature as desired to eliminate a scald hazard.

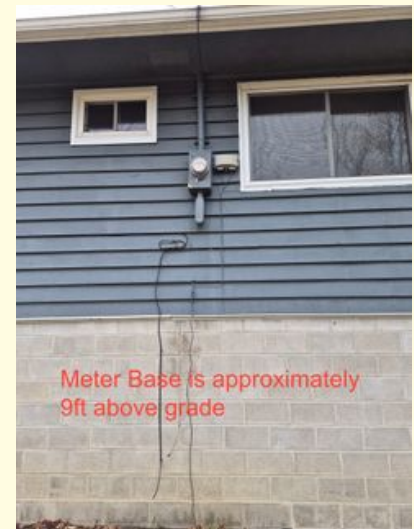
### **ES-1 Electric Service:**

The electrical meter base is installed higher than the acceptable mounting range typically required by the local supply authority. Meter bases must be positioned so the meter remains safely and readily accessible from finished grade. Adjustment is recommended to ensure proper accessibility for service personnel.

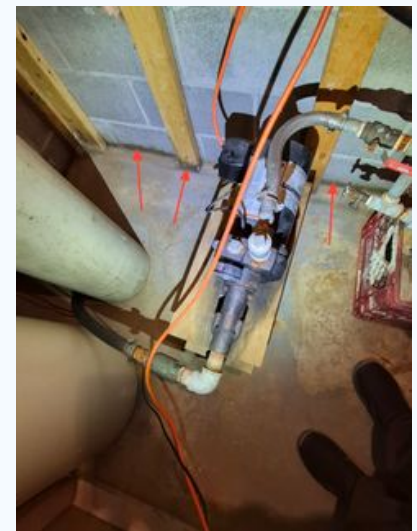
**SB-2 Basement Moisture:**  
**WATER STAINS NOTED IN BASEMENT**

Water stains were noted on some of the basement finishes, indicating the basement has experienced prior moisture control problems. Inquire with the seller for any history of moisture intrusion and make all repairs to exterior drainage as recommended in this report, as this will reduce the chances of basement moisture. Additional basement waterproofing may be needed. The scope and urgency of additional repairs have a great deal to do with your plans and expectations for this space. The space was dry at the time of inspection, but conditions can change seasonally.

- This basement does not look well-suited to finishing without first waterproofing.
