# Sample Report

This report is prepared exclusively for **Clients**  
Inspected On: **04-04-2026**

Outline Home Inspections  
(705) 879-6142

Dillon Koolhaas

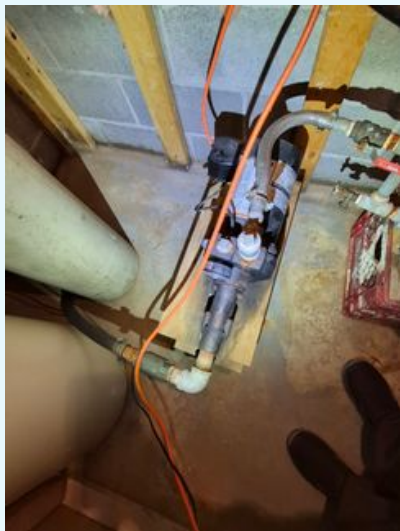
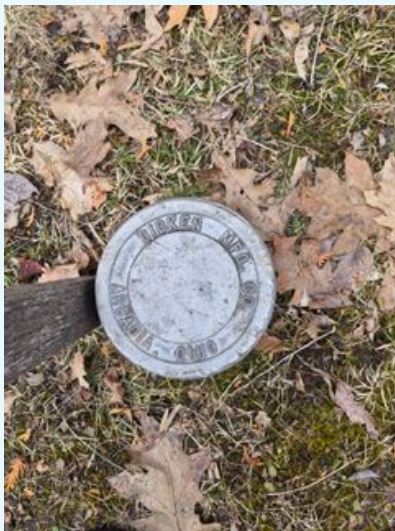
### **P-2 Water Service Supply: PRIVATE WELL**

Well equipment was noted for the water supply. Inspection of the well, water supply, and water quality are beyond the scope of this inspection.

I recommend hiring a well specialist to inspect and evaluate the well and well water. Well equipment: the pump and captive storage tank have limited service lives and often require updating on a 20-year schedule. There are other elements of a well system that should be evaluated as well, such as the well production, often tested in a draw-down test, water quality, and well depth.

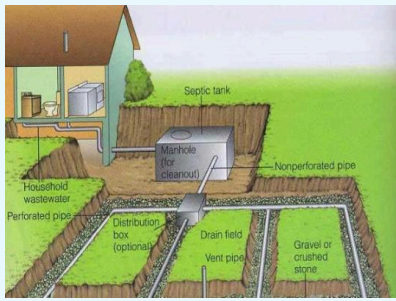
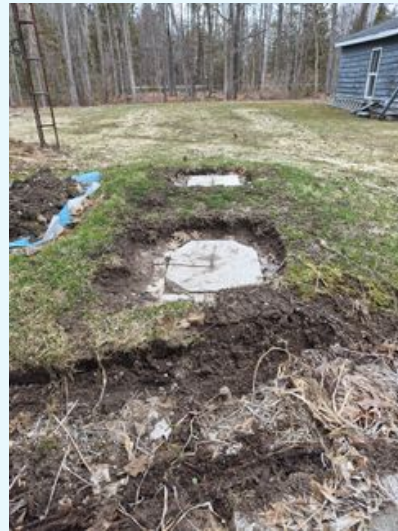
### **P-5 Waste Pipe and Discharge: ONSITE SEPTIC SYSTEM**

Based on visible components, this property appears to have a private on-site septic system. These are specialty systems and are excluded from this inspection. Comments in this report related to this system are made as a courtesy only and are not meant to be a substitute for a full evaluation by a qualified specialist. Generally, septic tanks should be pumped and inspected every 3 years. Depending on the type of system and municipal regulations, inspection and maintenance may be required more frequently, often annually. I recommend:

- Investigating any information about this system's maintenance and repair history
- Reviewing any documentation available for this system
- Learning inspection and maintenance requirements for this system
- Hire a qualified specialist to evaluate, perform maintenance and make repairs as needed

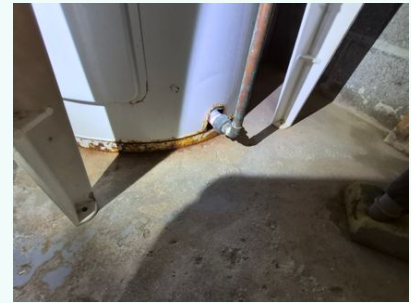
### **WH-2 Water Heater:** **RUST FORMING**

Rust is forming at the base of the water heater, suggesting a past leak or flooding. No active leakage was observed during the inspection. Monitor for any leaks or worsening of corrosion.

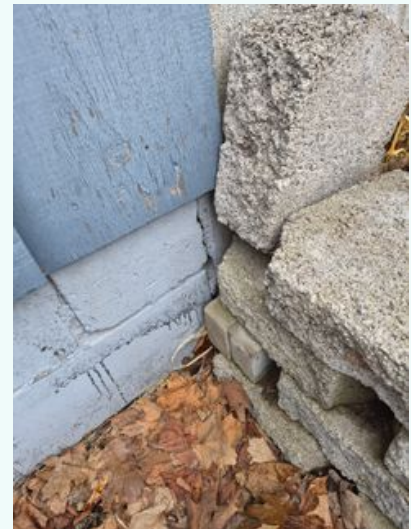
### **SB-1 Foundation:** **TYPICAL FOUNDATION CRACKS NOTED**

Small cracks were noted in the foundation. The purpose of the foundation is to connect the weight of the building to well-compacted soils below the house so that the house does not move or settle. Concrete cracking can indicate poorly compacted soils below the house which could require repair. ***It is not possible to determine or verify the cause of these cracks during a visual inspection.*** The easiest way to prevent ongoing settlement in buildings is by controlling roof runoff and site drainage to promote dry soils around the foundation; wet soils do not bear weight well. This will also help to prevent moisture problems. In my experience, small cracks like these are common in concrete foundations of this age.

- Monitor these cracks. If continued movement is noted, seek additional opinions from a structural engineer or qualified contractor to determine an accurate scope and urgency for repair.
