Inspection report for the property at
Sample Report

This report is prepared exclusively for **Clients**
Inspected On: **04-04-2026**

Outline Home Inspections
(705) 879-6142

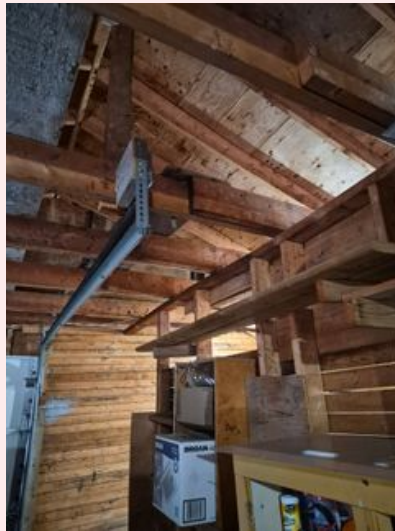
poor garage door support (2)

⚠️ **G-1 Garage General:** Extensive repairs are needed to the detached garage. Hire a licensed general contractor to further evaluate and repair. Examples of observations noted during inspection include:

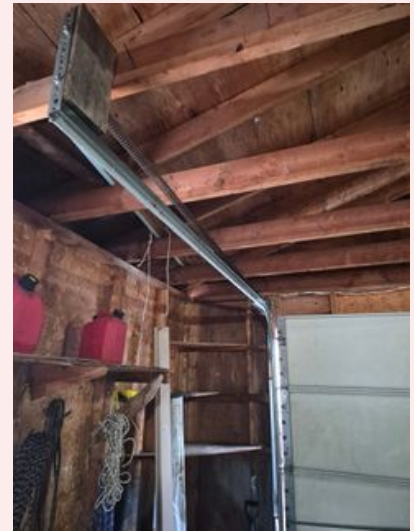
poor garage door support

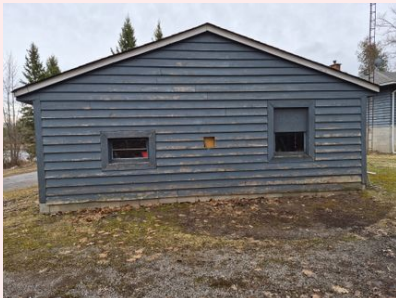
Opening in siding, rotted siding

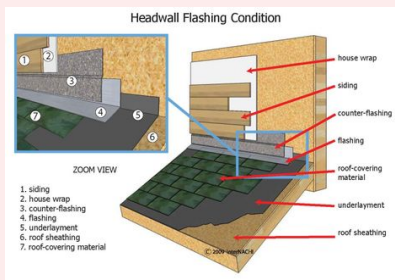
⚠️ RCG-1 Roof Materials: The headwall flashing has separated from the wall, creating a pathway for moisture to enter the structure. Signs of moisture damage are noted on the interior beneath this section. A qualified roofing contractor should repair or replace the flashing to restore proper weather protection.

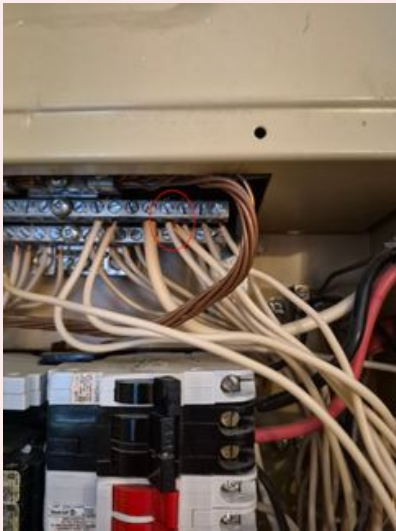
double tapped neutral wires

A [Federal Pioneer Electric Stab Lok](#) brand electric panel was noted. This is an obsolete brand of panel with a reputation for failing and malfunctioning breakers. Stab Lok electric panels are at greater risk of electrical fire and statistically less safe than any new electric panel. I recommend additional inspection of this electrical service by a licensed electrical contractor; updating this panel is recommended for improved reliability and safety. A number of observations were noted during the inspection:

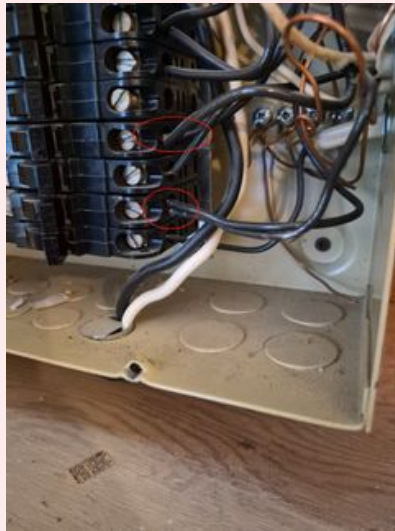
double tapped hot wires

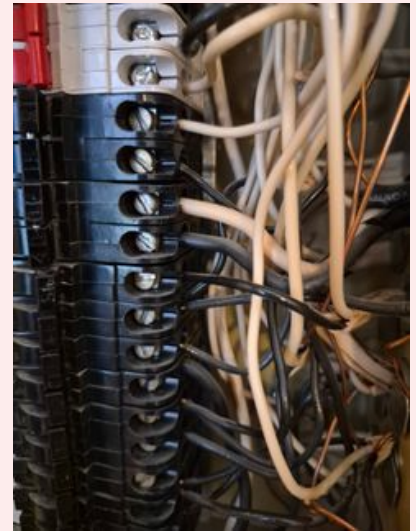
double taps and unlabeled "neutral" hot wires

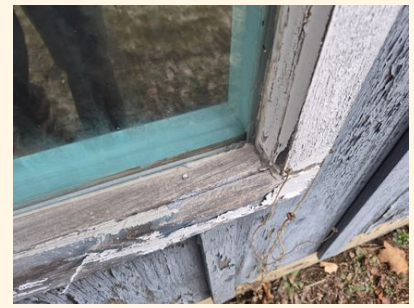
Many of the wood windows in this building are exposed to the weather and will require regular painting and sealing maintenance to preserve the windows and prevent decay. I checked the windows for wood decay and damage during inspection.

- Localized wood decay

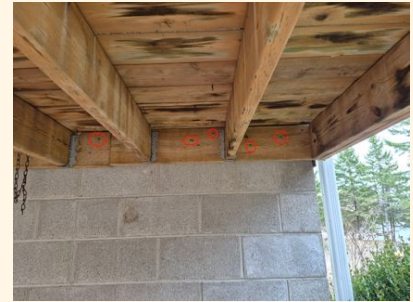
The deck ledger board has not been reliably connected to the house. This risks deck failure as the ledger attachment to the house can pull free. I recommend installing an attachment system that conforms to recommended minimum standards. The Town of Orangeville provides an excellent [Deck Construction Guide](#) for reference.

Hire a qualified deck contractor to further evaluate.

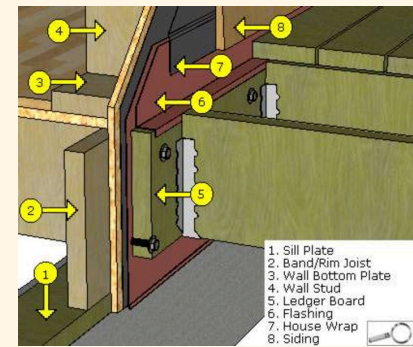
No flashings were noted between the deck ledger board and the home. This could allow water to get trapped between the deck and the house, causing rot and a conducive pest condition. This can be a difficult retrofit once the deck is constructed. No water damage was visible, but this could cause long term moisture control problems at the deck.

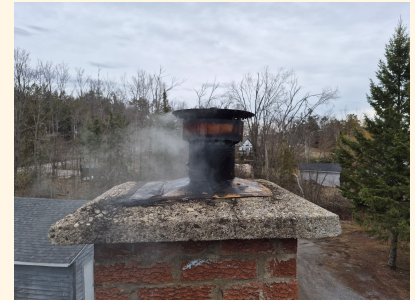
The chimney needs cleaned and repaired. Creosote is building up and can quickly choke a metal chimney cap. The masonry cap is cracked and spalling. Have this further investigated and repaired by a qualified mason or chimney sweep as recommended.

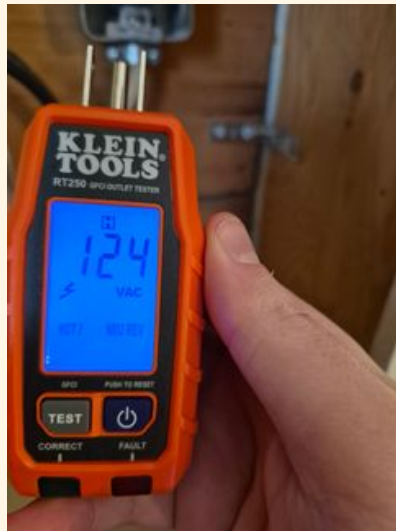
Receptacle next to electrical panel

Reverse polarity was noted at one of the electric receptacles. This is when the hot and the neutral wires have been wired backwards. This is a potential safety issue that should be corrected by a licensed electrical contractor.

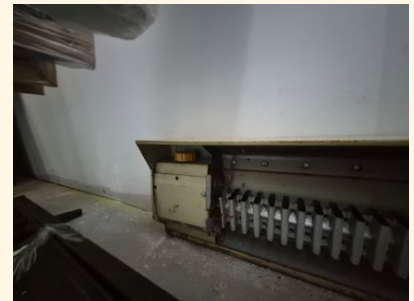
- Basement Bedroom (south wall)

Inoperative baseboard heaters were noted - they did not respond to testing. Hire a licensed electrician to repair or replace as needed. Locations noted during inspection include:

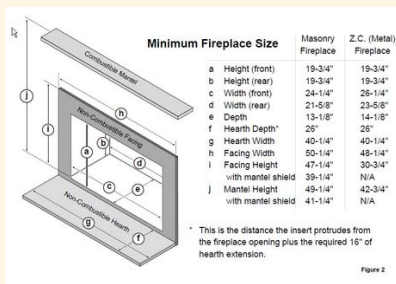
A wood stove has been inserted into a masonry firebox and the non-combustible hearth was not extended. This means the hearth is no longer an adequate size to protect the floor from hot embers. Have this further investigated and repaired by a qualified chimney sweep or mason. Provide an adequate non-combustible hearth for the front of the wood stove for operational safety.

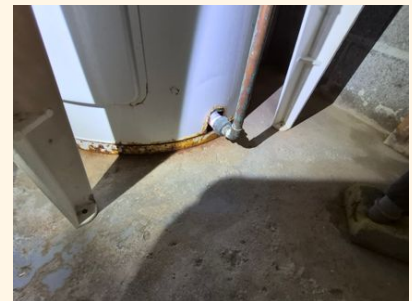
NO DRAIN PAN FOR WATER HEATER

No drain pan has been installed below the water heater here. A drain pan is recommended under water heaters that are located in finished spaces or where a leak could damage finishes. Where a pan does not already exist, the tricky part is providing a drain to the outside. A pan without a drain is often of limited benefit/protection. For improved protection from accidental water heater leaks and where a drain is difficult to install, consider a pan with a moisture alarm and a flood-safe device.

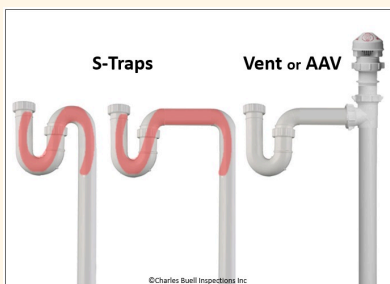
K-2 Sinks and Faucets: S-TRAP CONFIGURATION NOTED

An S-trap was noted in the kitchen sink. This is an older style of waste piping that risks siphoning the trap and is no longer allowed. This should be further investigated and repaired by a licensed plumber to ensure reliable performance. Often an air admittance valve can be used to correct this configuration. Please note that trap siphoning could allow sewer gas to enter the house.

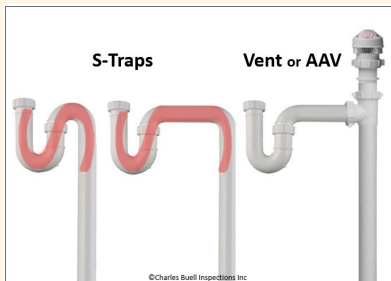
🔧 **BB-1 Sinks and Cabinets: S-TRAP CONFIGURATION NOTED**

An S-trap was noted in the basement bathroom sink. This is an older style of waste piping that risks siphoning the trap and is no longer allowed. This should be further investigated and repaired by a licensed plumber to ensure reliable performance. Often an air admittance valve can be used to correct this configuration. Please note that trap siphoning could allow sewer gas to enter the house.

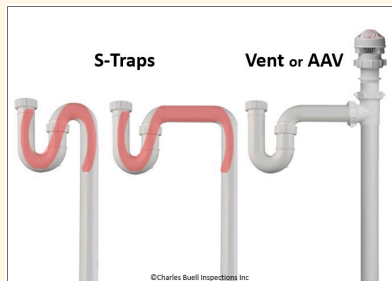
🔧 **MFB-1 Sinks and Cabinets: S-TRAP CONFIGURATION NOTED**

An [S-trap](#) was noted in the main bathroom sink. This is an older style of waste piping that risks siphoning the trap and is no longer allowed. This should be further investigated and repaired by a licensed plumber to ensure reliable performance. Often an air admittance valve can be used to correct this configuration. Please note that trap siphoning could allow sewer gas to enter the house.

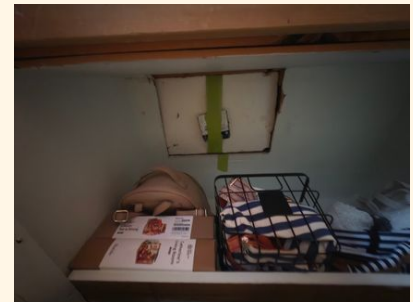
**A-1 Attic Access:**
SMALL ATTIC ACCESS POINT

The attic access hatch is too small and cannot be entered. Standards for attic access size is 30"/22" to provide access to this space to work and make repairs/improvements.

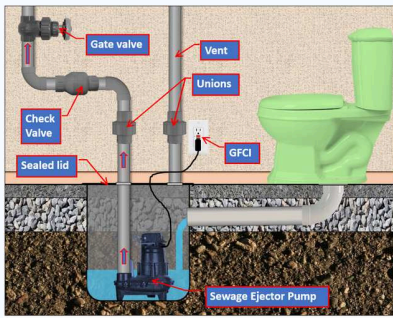
A sewage ejector system was noted serving the basement bathroom.

- Opening up the sewage ejector system is beyond the scope of a home inspection.
- I did not see a moisture alarm installed; these are recommended to alert you should the pump fail.

Have the sewage ejector system further evaluated and repaired / serviced as recommended by a qualified plumbing contractor.

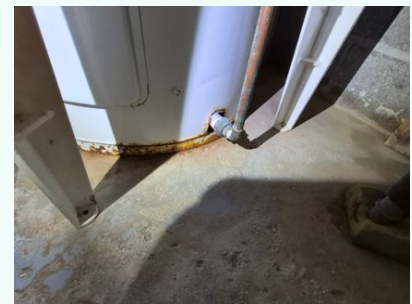
WH-2 Water Heater: **RUST FORMING**

Rust is forming at the base of the water heater, suggesting a past leak or flooding. No active leakage was observed during the inspection. Monitor for any leaks or worsening of corrosion.
